BCA BE Seminar 2022

Buildings: What Can Go Wrong

Case Studies of Excavation and Tunnelling Failure

Building and Construction Authority

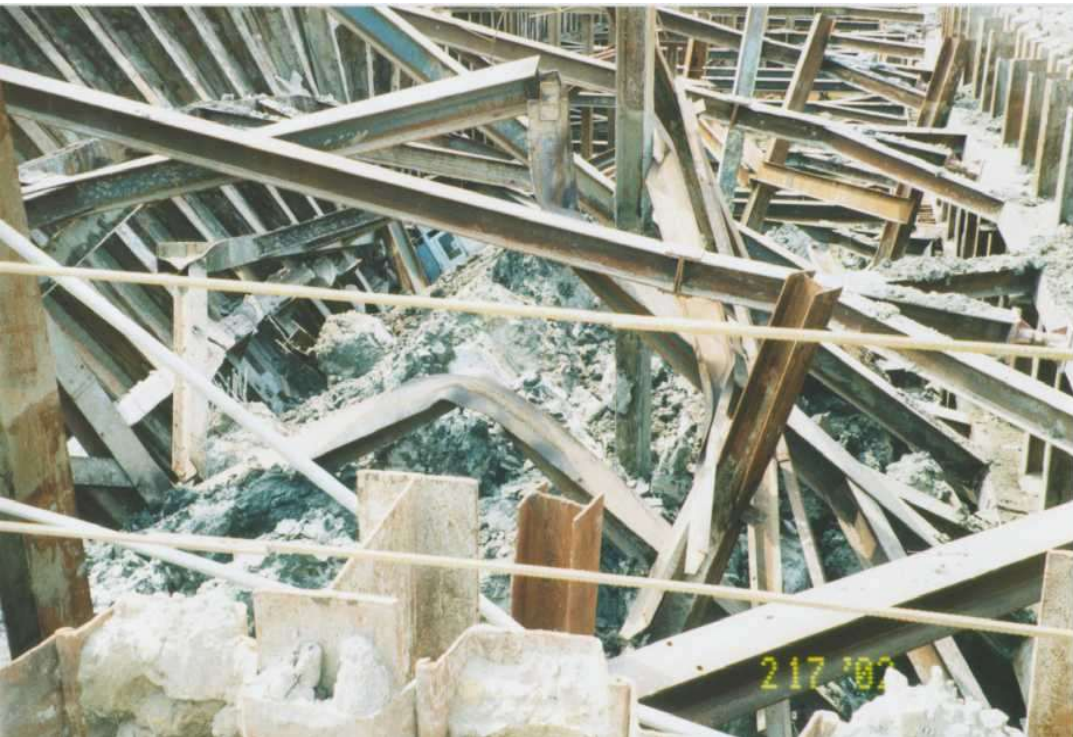
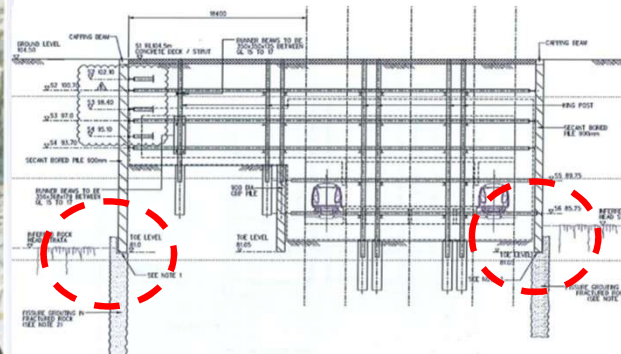
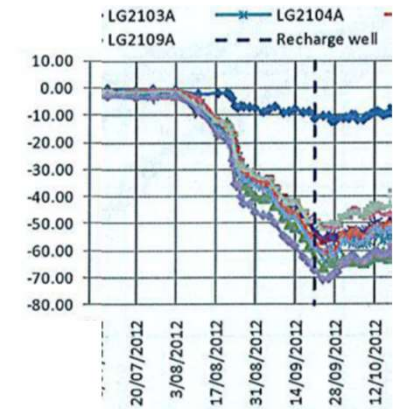
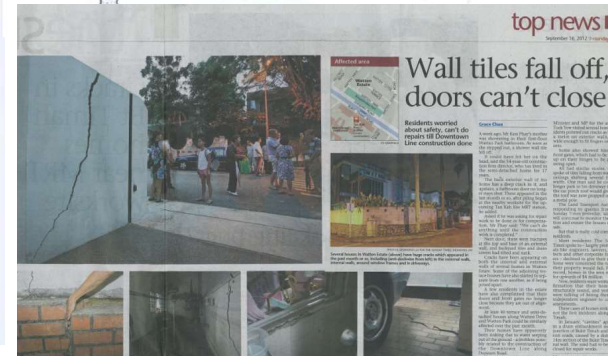
Basal heave failure at strutted excavation for tunnel construction

Inadequate seepage cut-off at ERSS wall

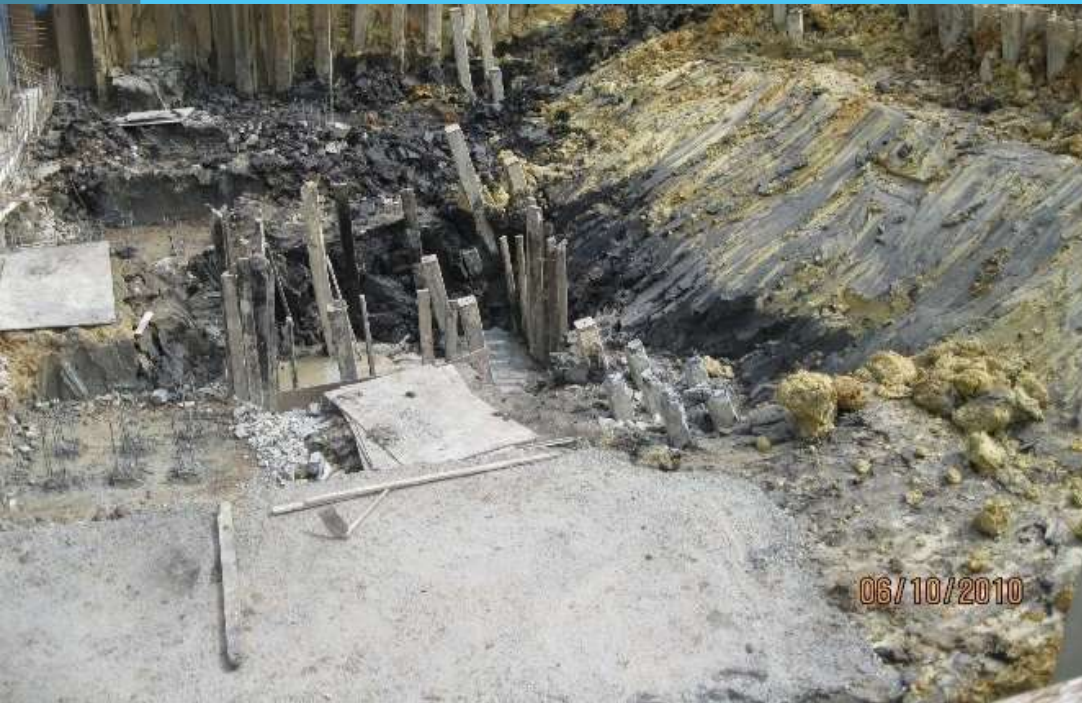
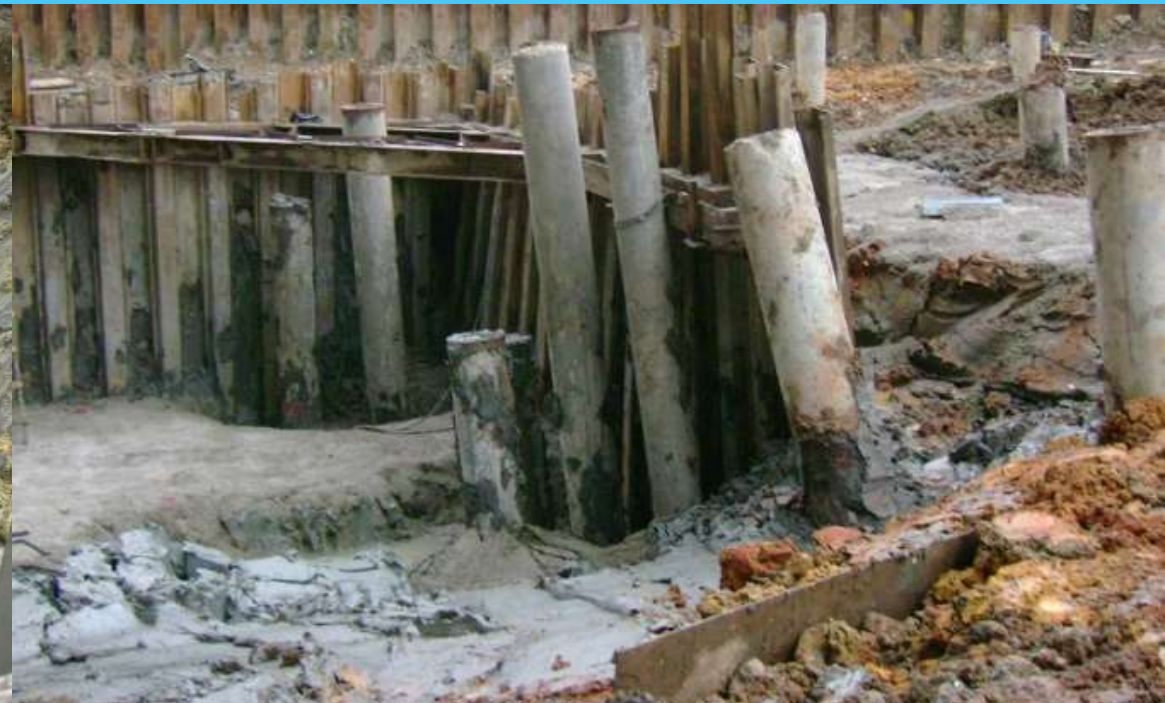
Excessive pile movement caused by unstable internal slope within excavation in soft clay

Damaged to RC piles, spun piles and bored piles were reported for these sites

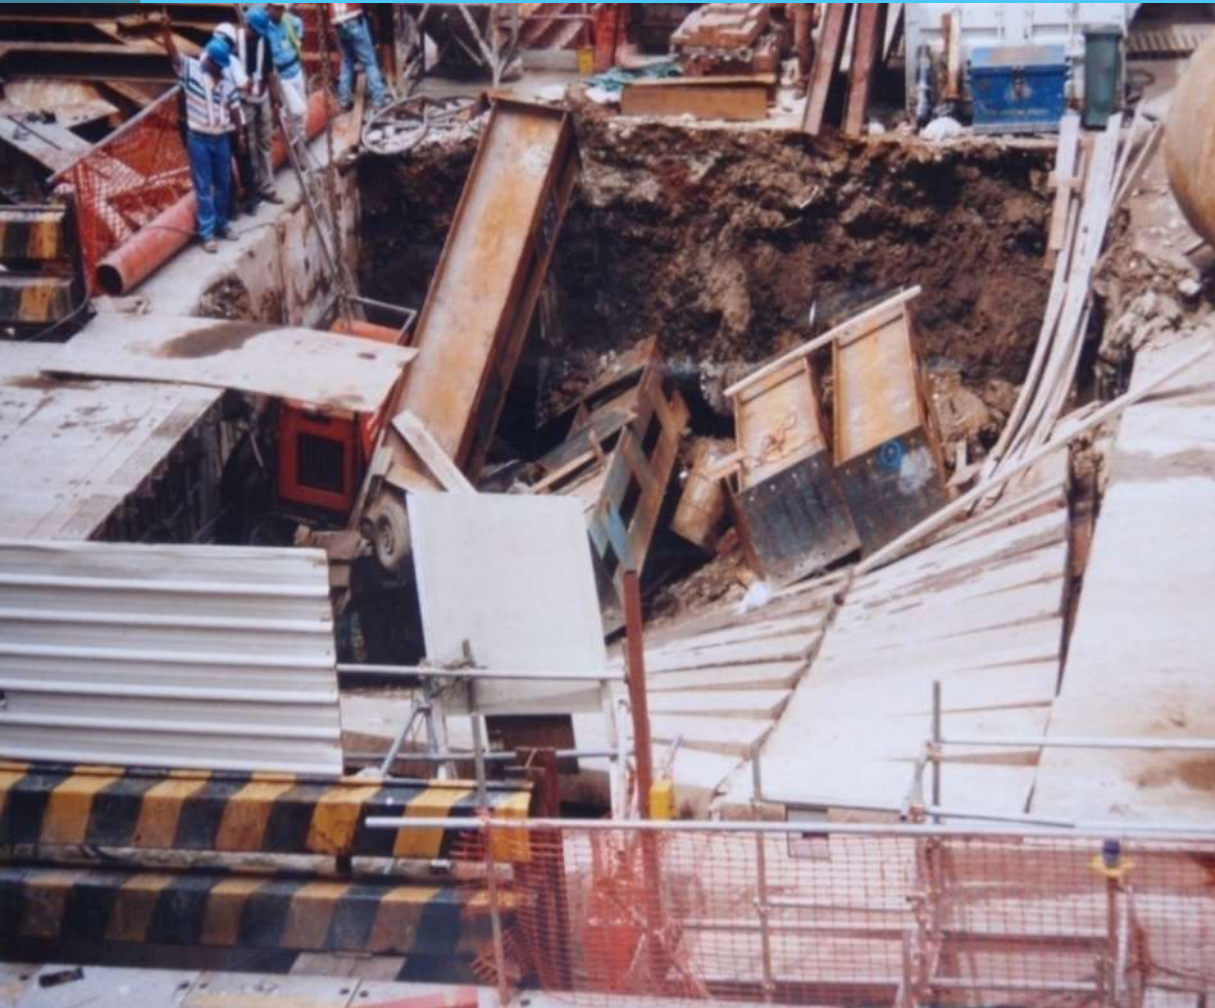
A sink hole behind a utility gap where the RC laggings were not constructed at each localised stage of excavation and left unsupported

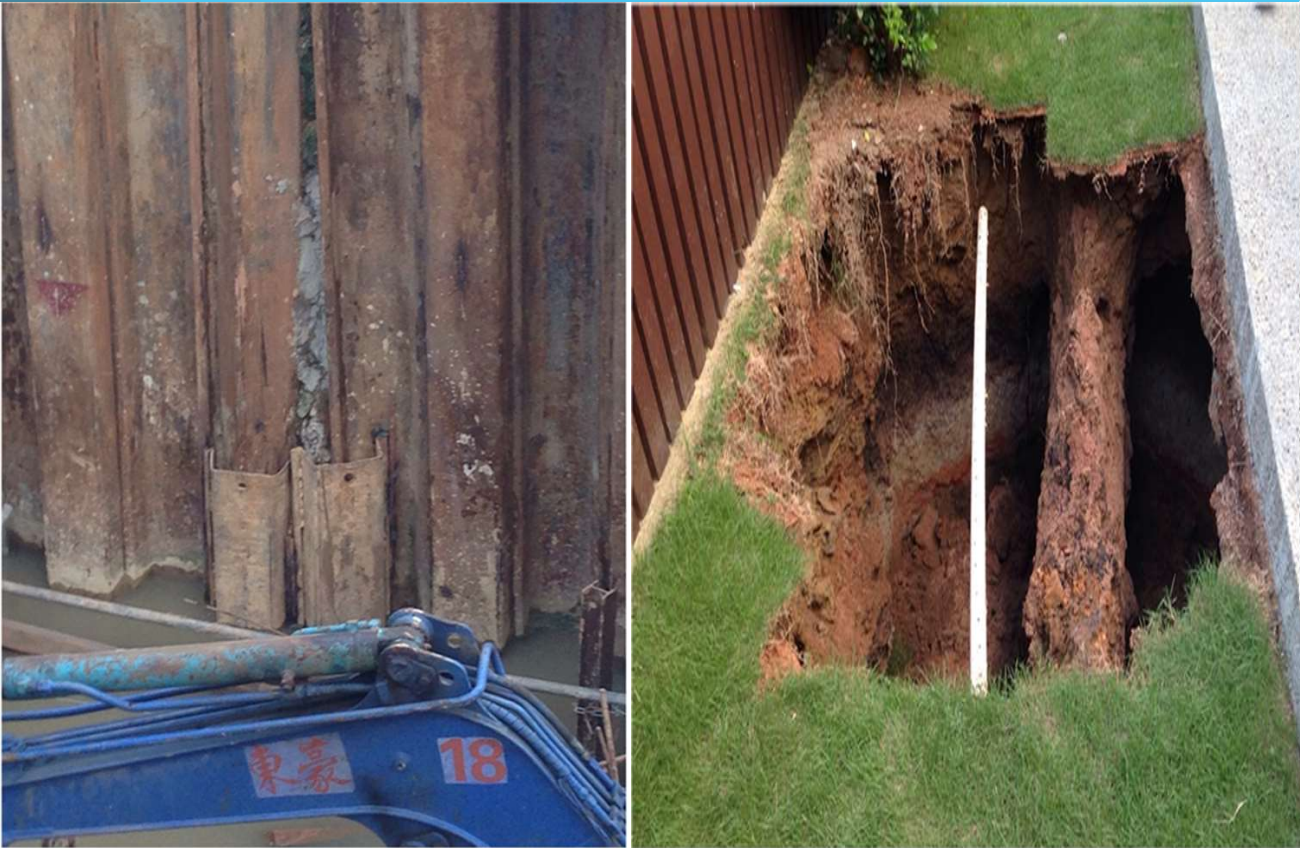
Fatal incident involving a man fallen into sinkhole in sandy ground

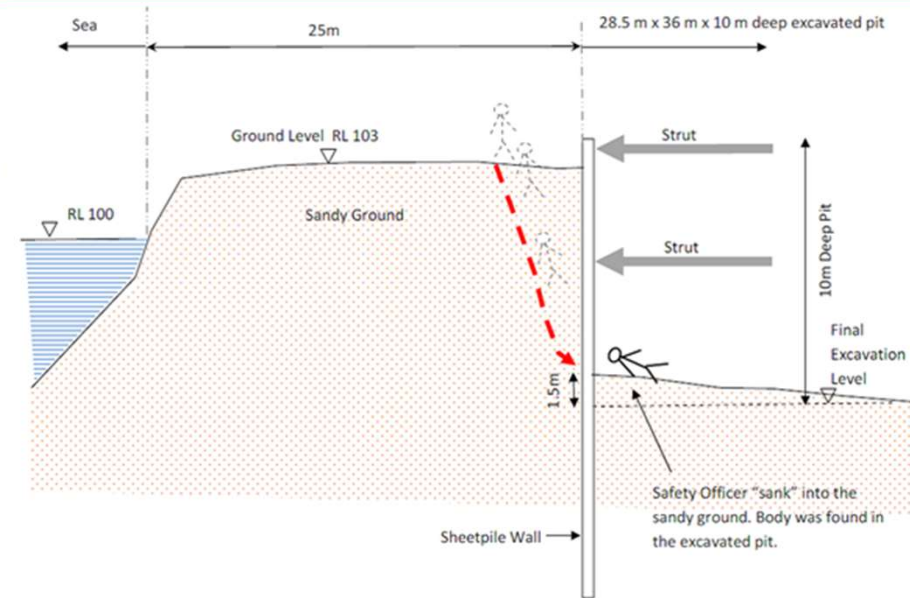
Sinkhole caused by sheet pile gaps

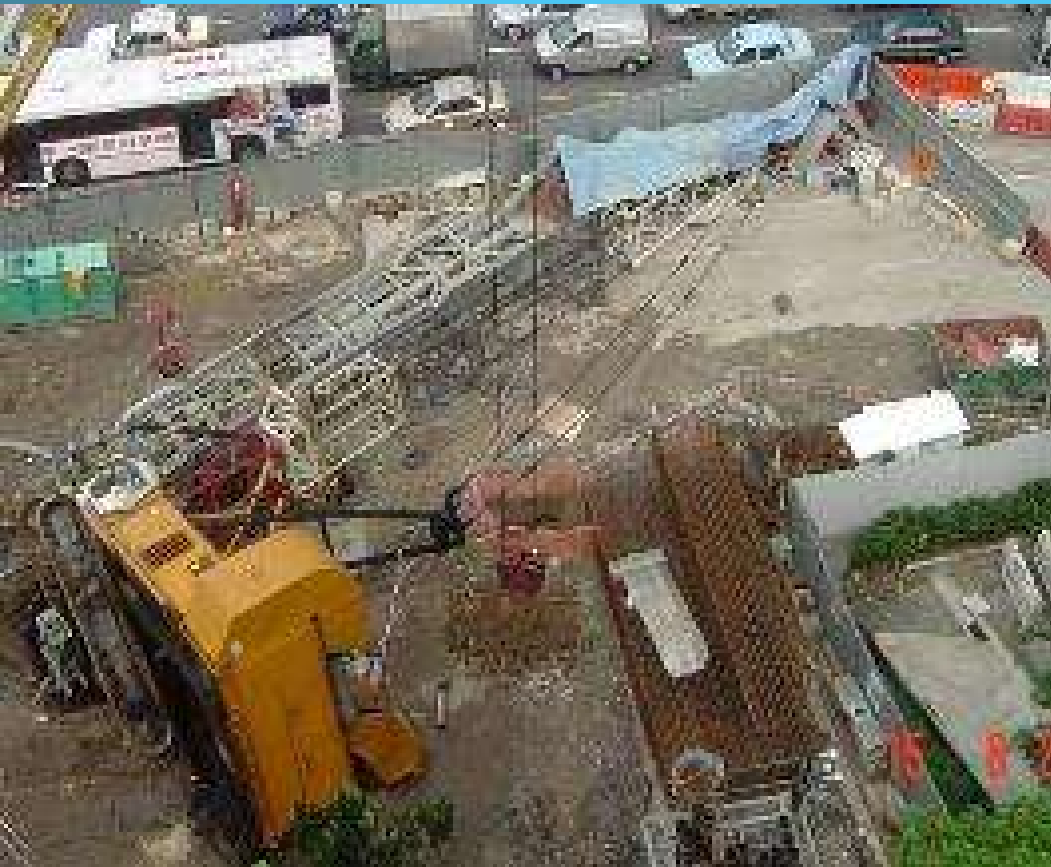
A localised collapse of diaphragm wall during trenching which trigger an incident of crane collapsed

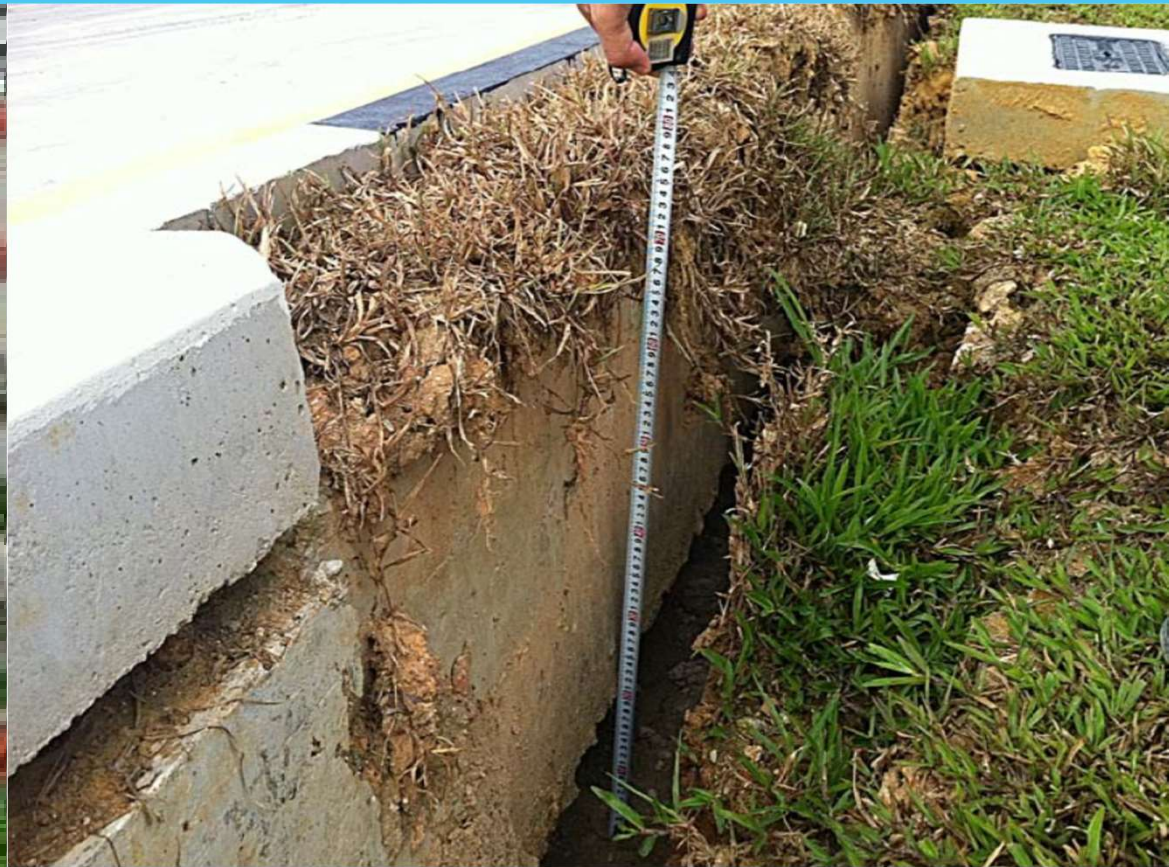
Uncontrolled removal of pipe pile ERSS wall caused excessive ground settlement

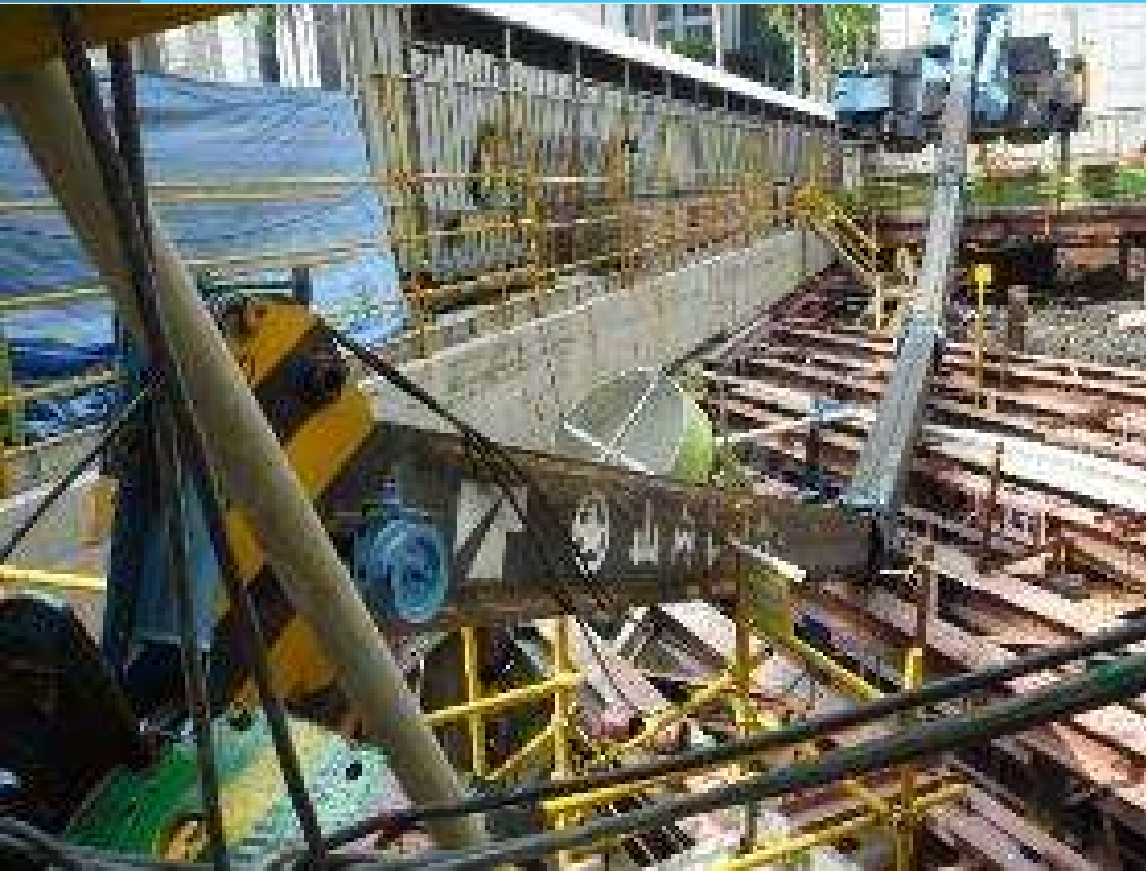
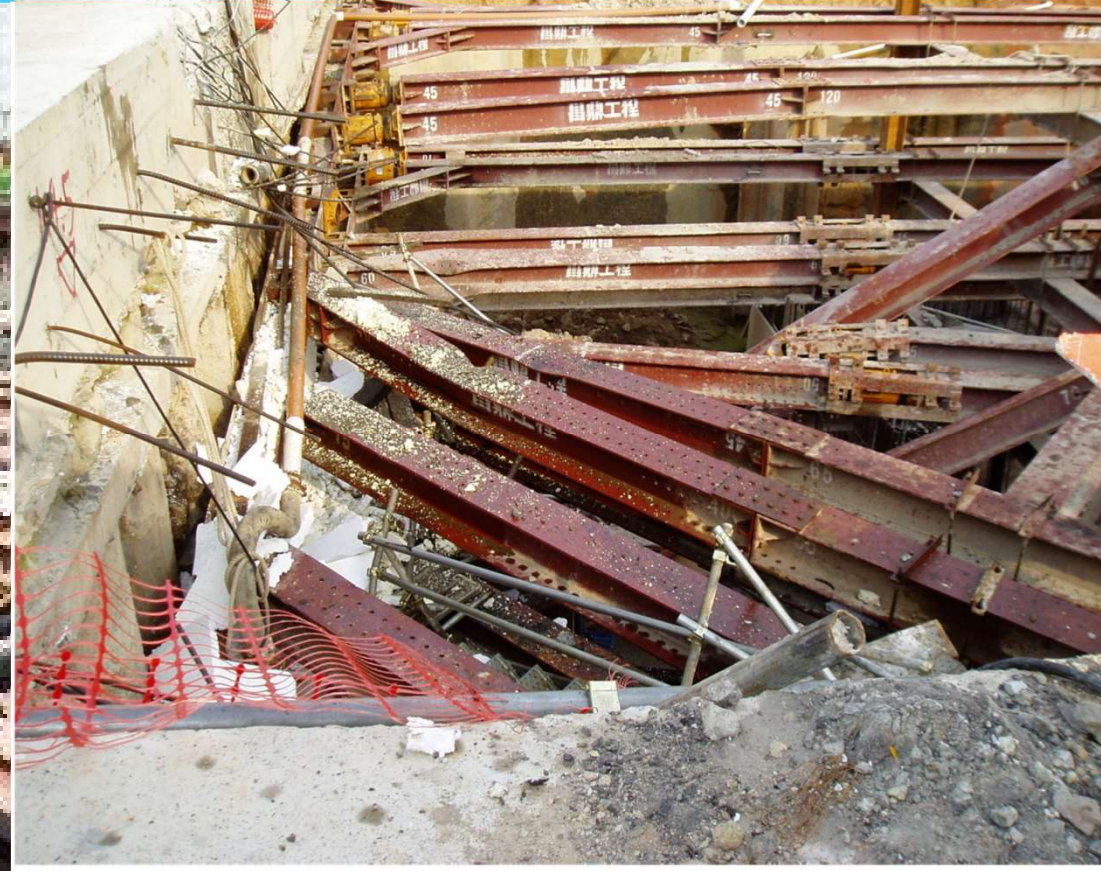
Example of crane incident affecting ERSS support where the first layer strutting was dislodged due to accidental impact loads

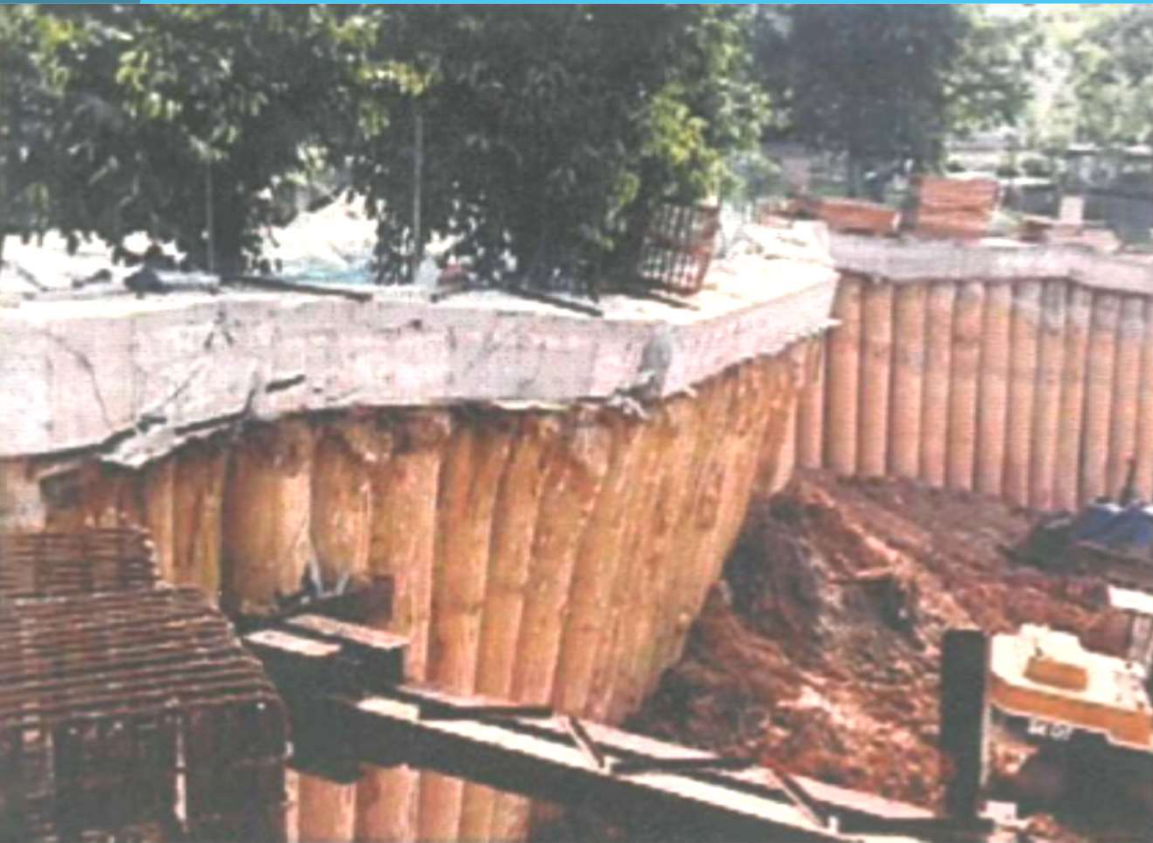
The deflected CBP wall

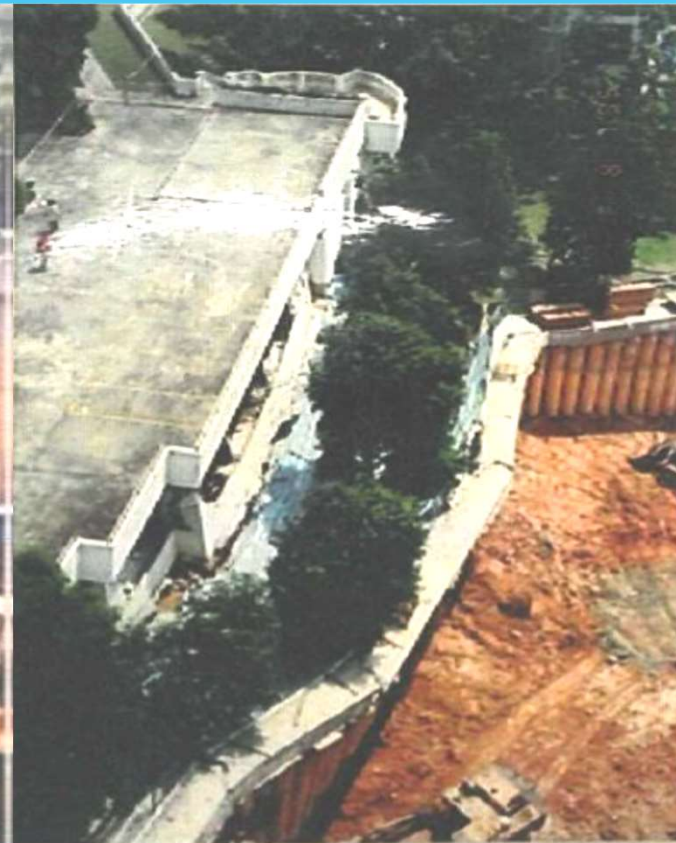
The CBP wall deflected away from single storey carpark.

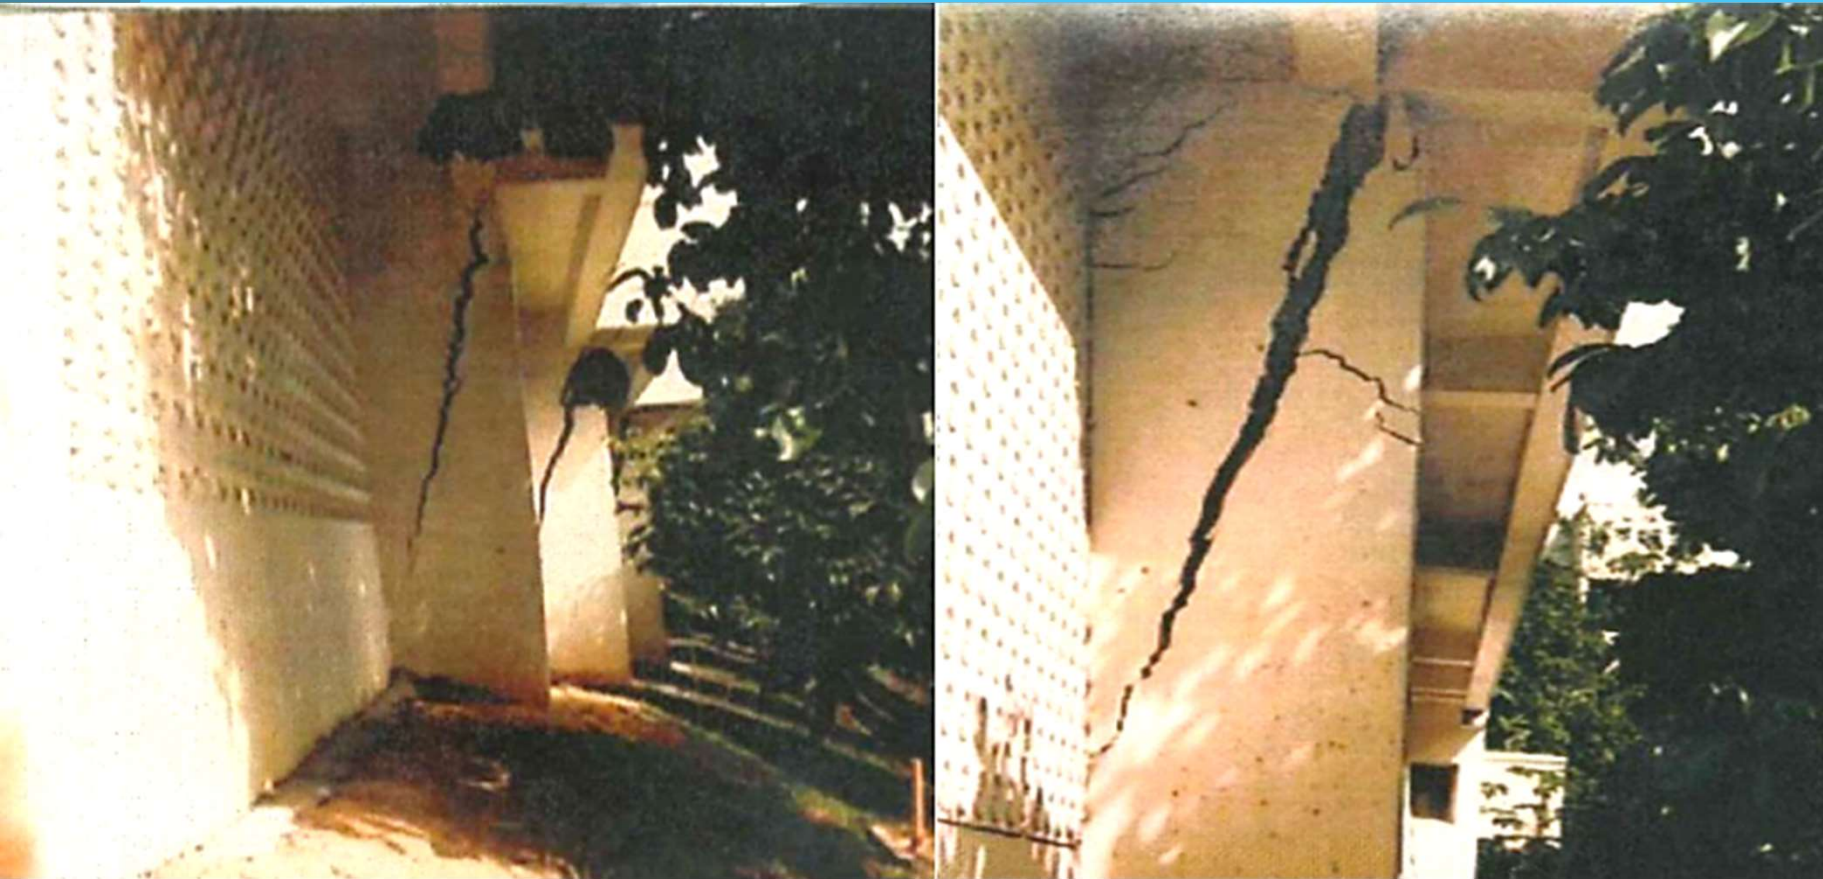
Views of carpark columns with large diagonal shear cracks

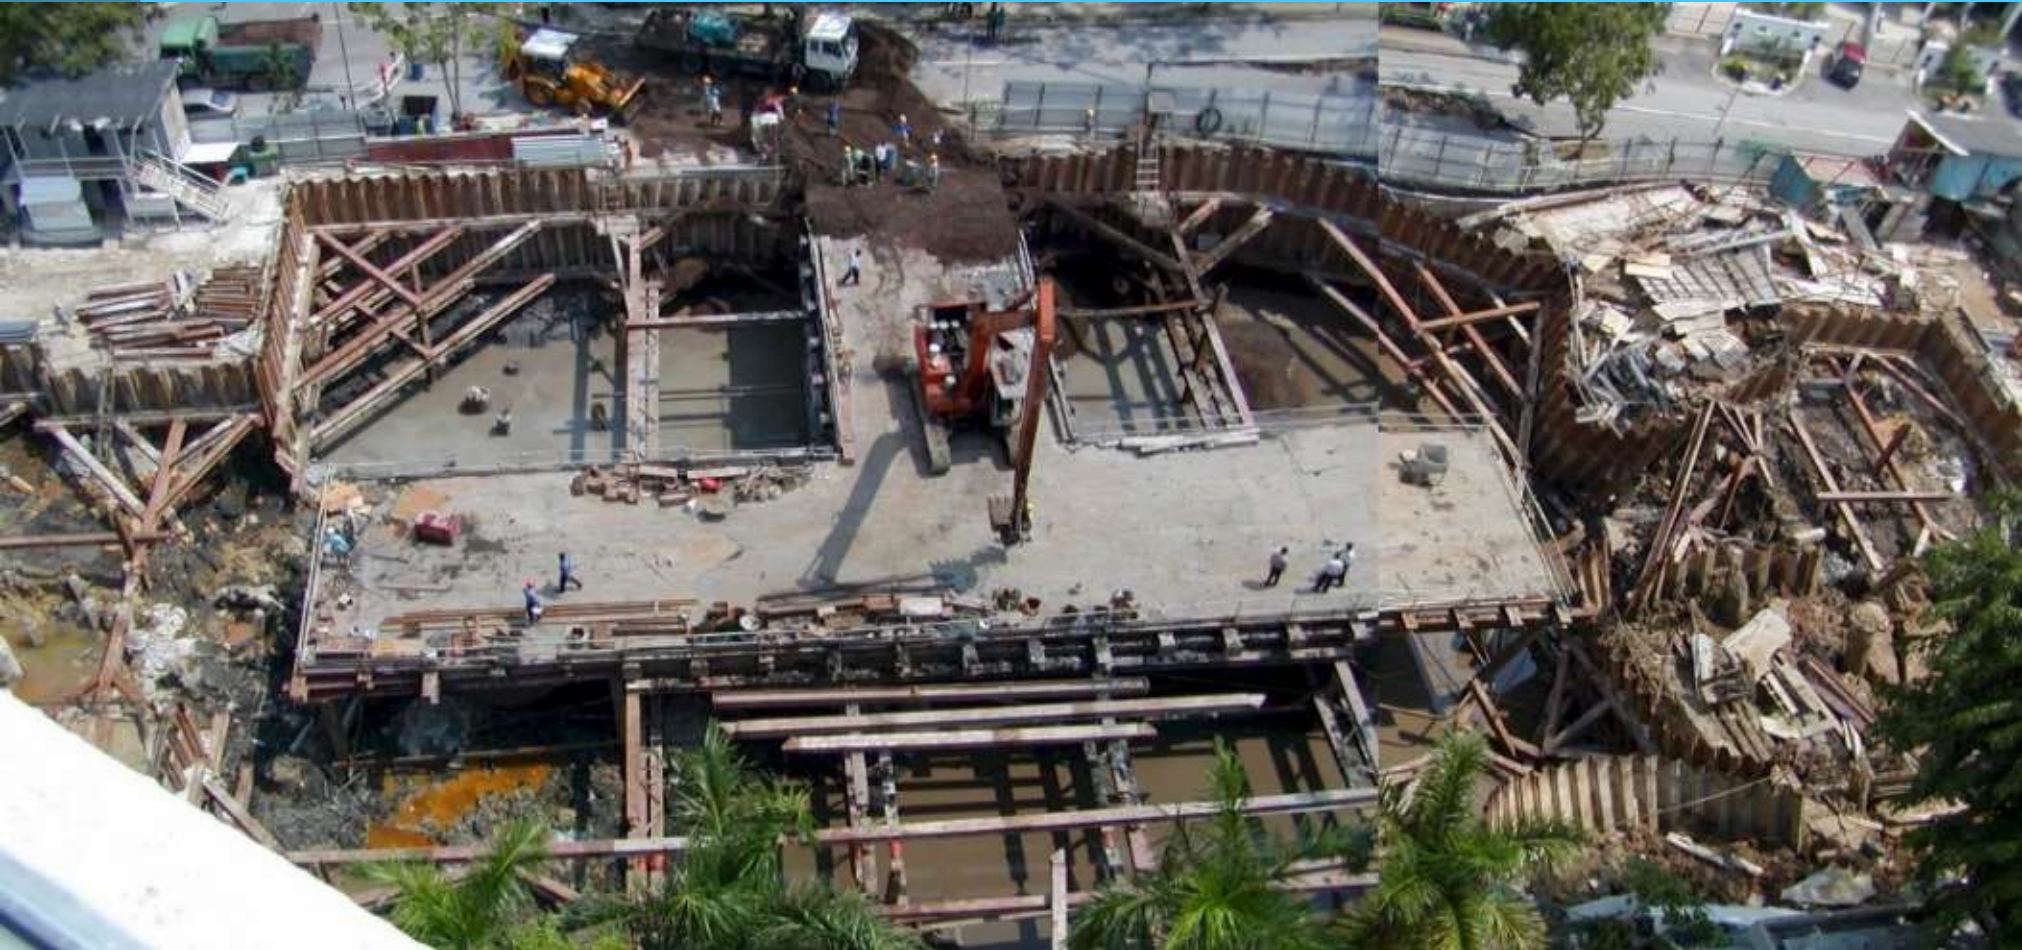
After the collapse, overall view of the site

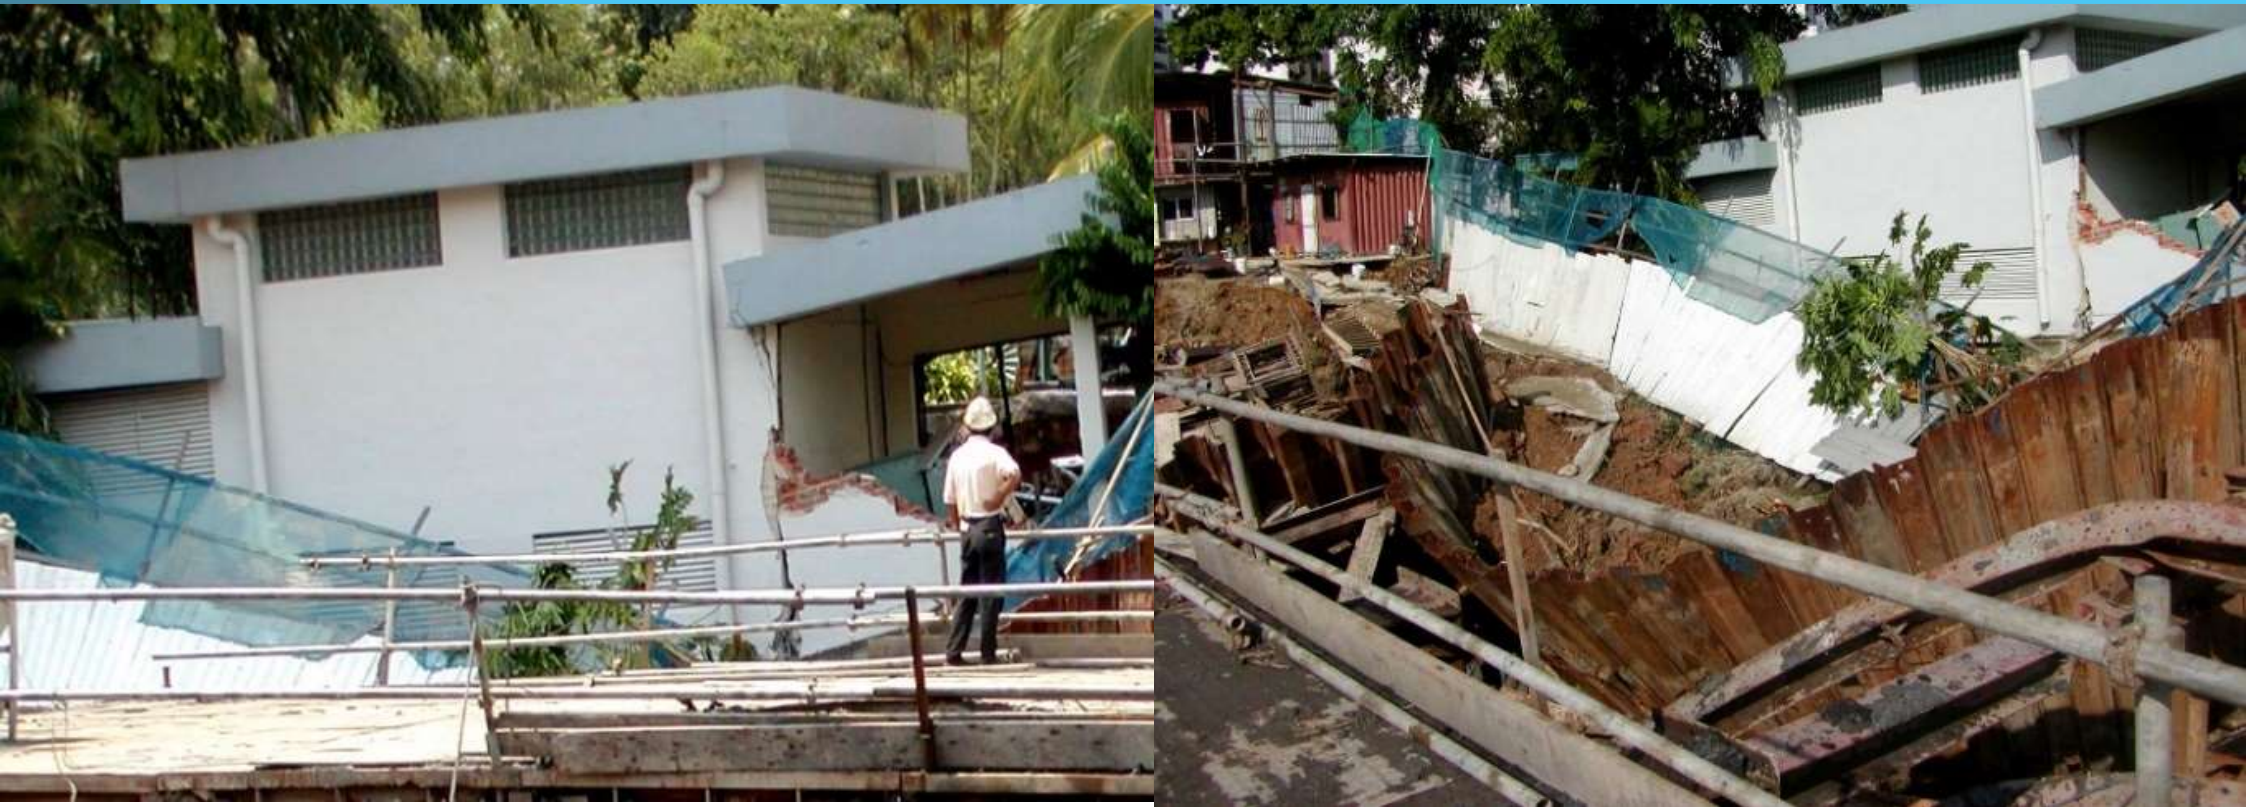
After the collapse, road in front of site and adjacent existing substation

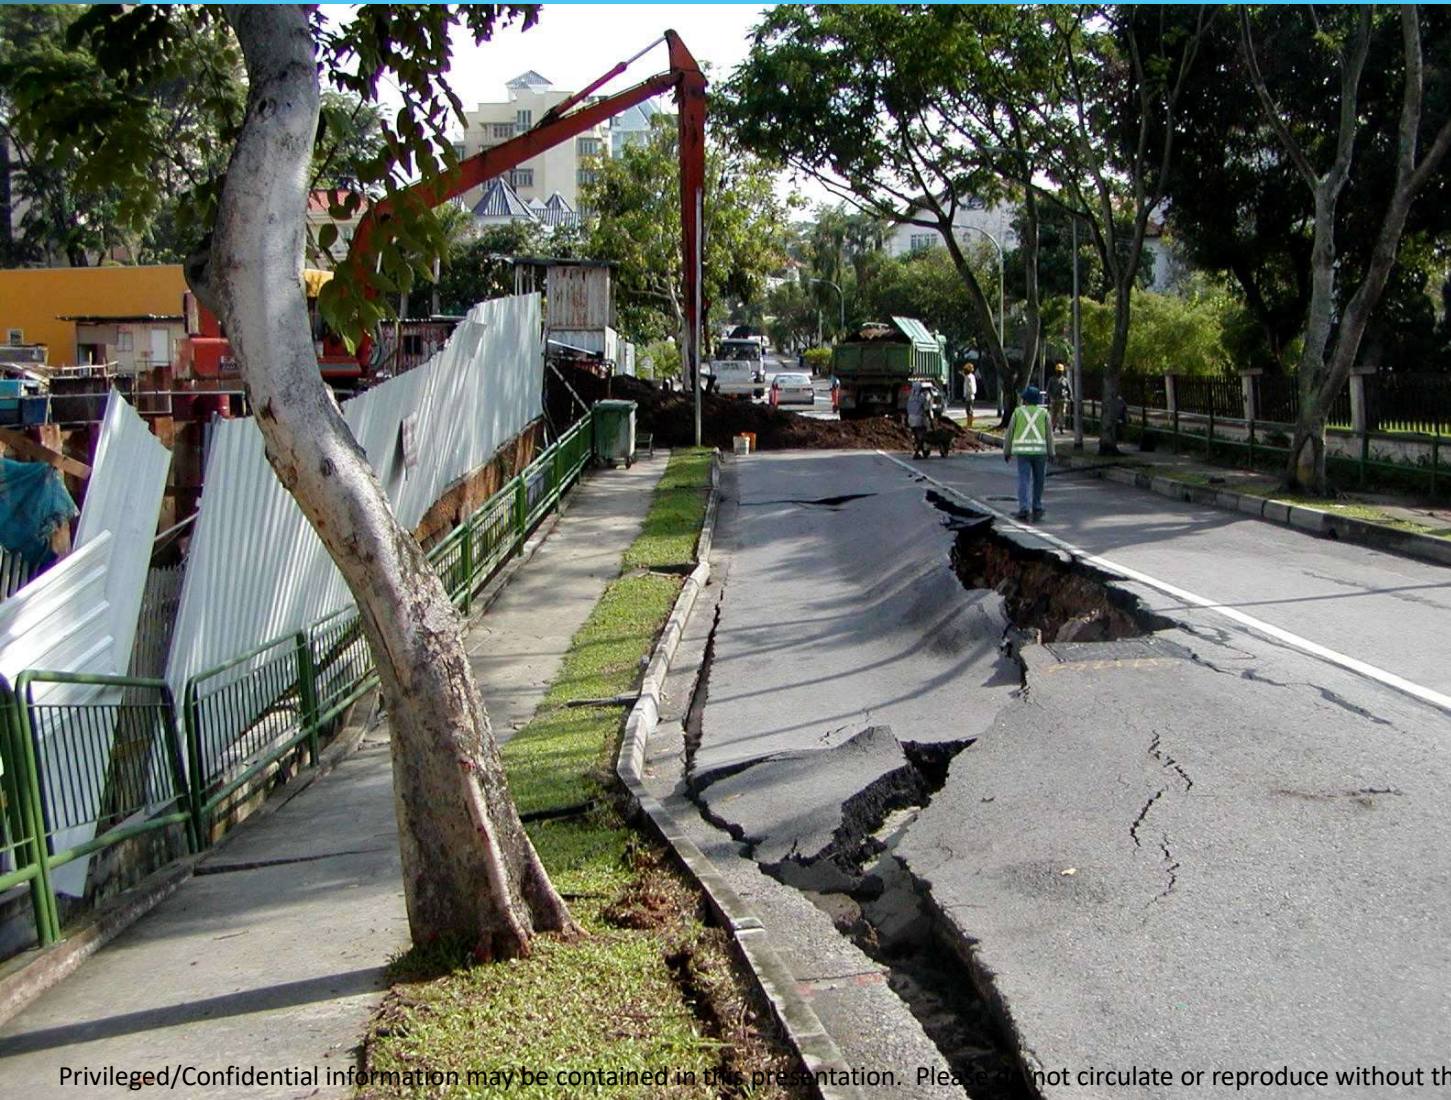
After the collapse, road in front of site and adjacent existing substation

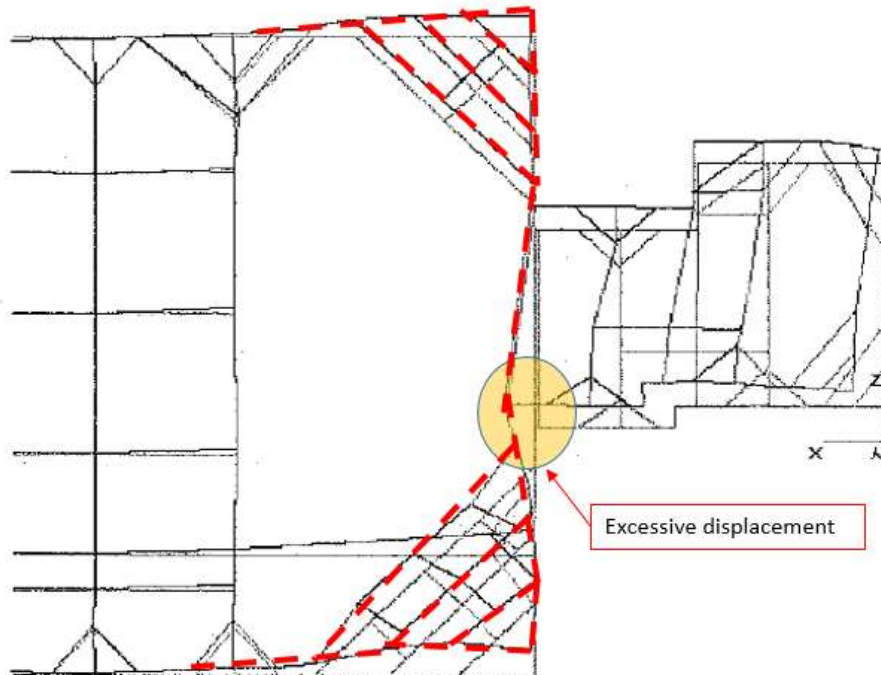
Deformed shape of the temporary sheet pile wall system

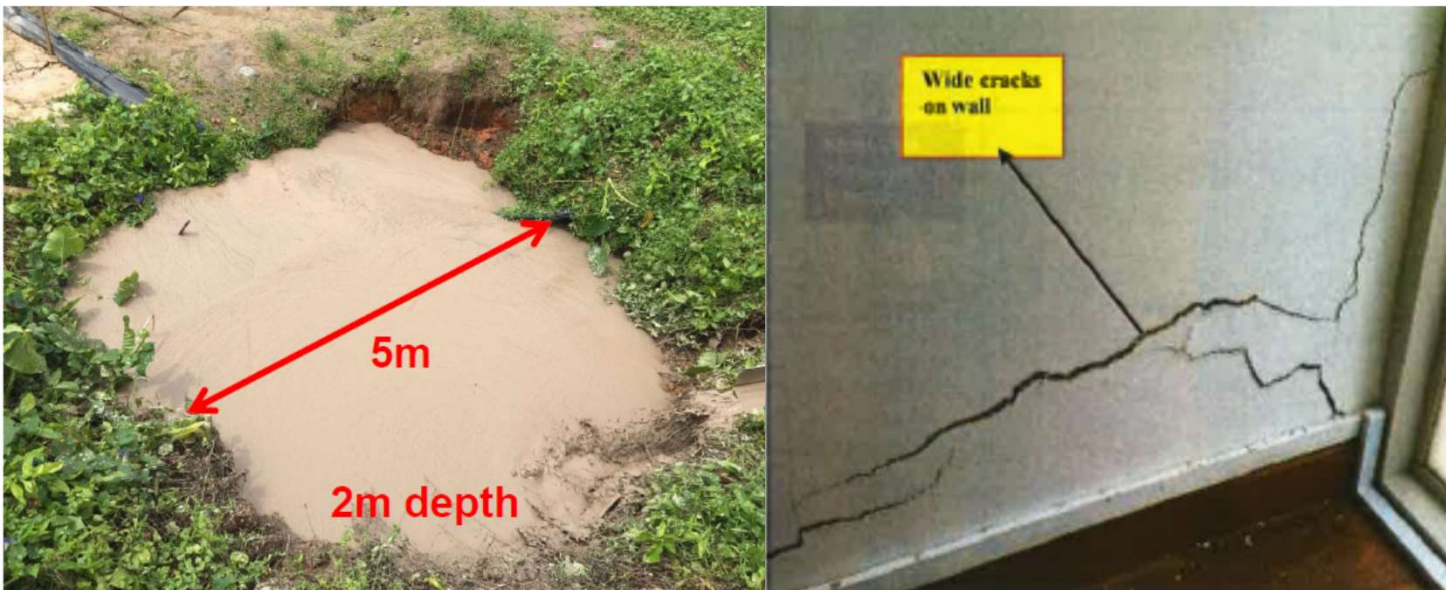
Building damage due to nearby tunnelling

- Sinkhole at 4m away from the existing pile foundation of the house
- Building suddenly settled by 28mm
- Building damaged with large cracks
- Residents decanted immediately after the incident

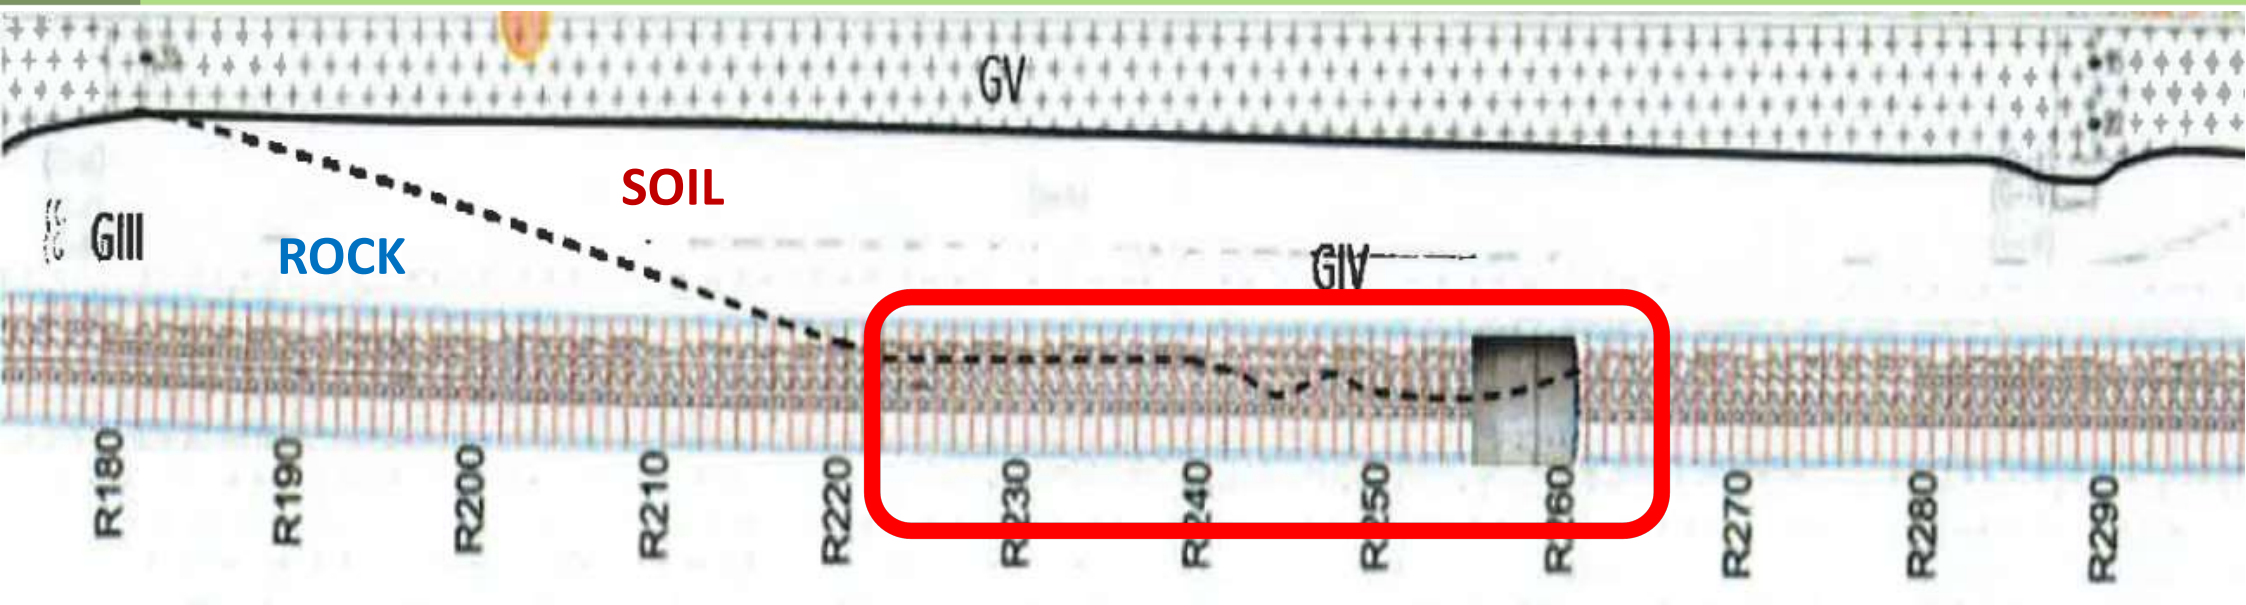
Mixed face zones (GIV/GIII) over 40 rings were encountered during actual tunnelling

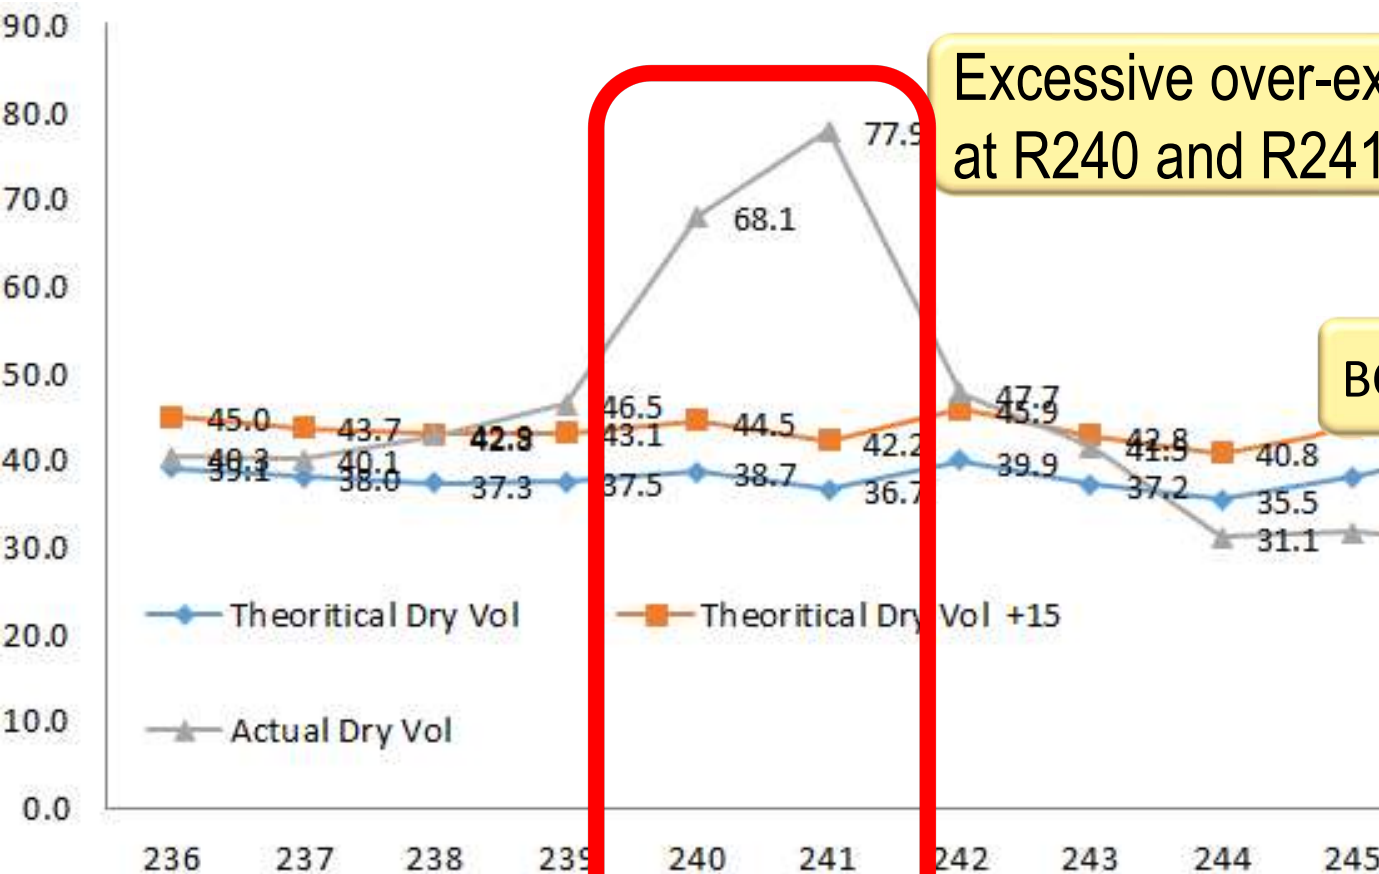
Excessive over-excavation at R240 and R241.
