BCA BE Seminar 2022

Buildings: What Can Go Wrong

Case Studies of Excavation and Tunnelling Failure

Building and Construction Authority

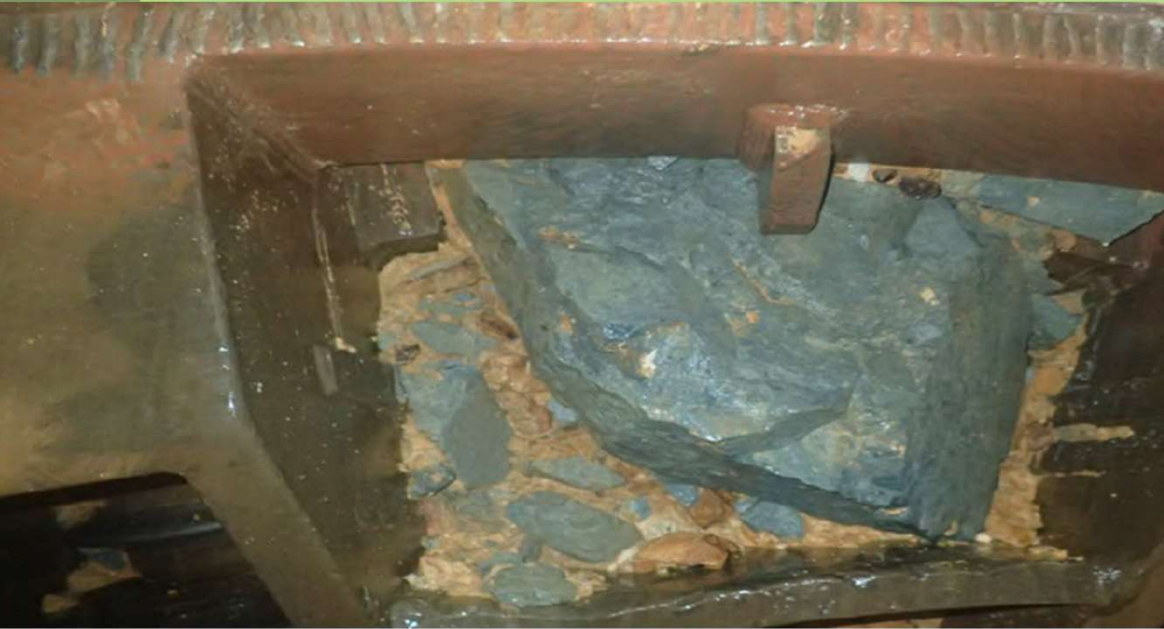
Boulders/rock debris stuck at cutterhead

Install additional plates to minimize risks of jamming

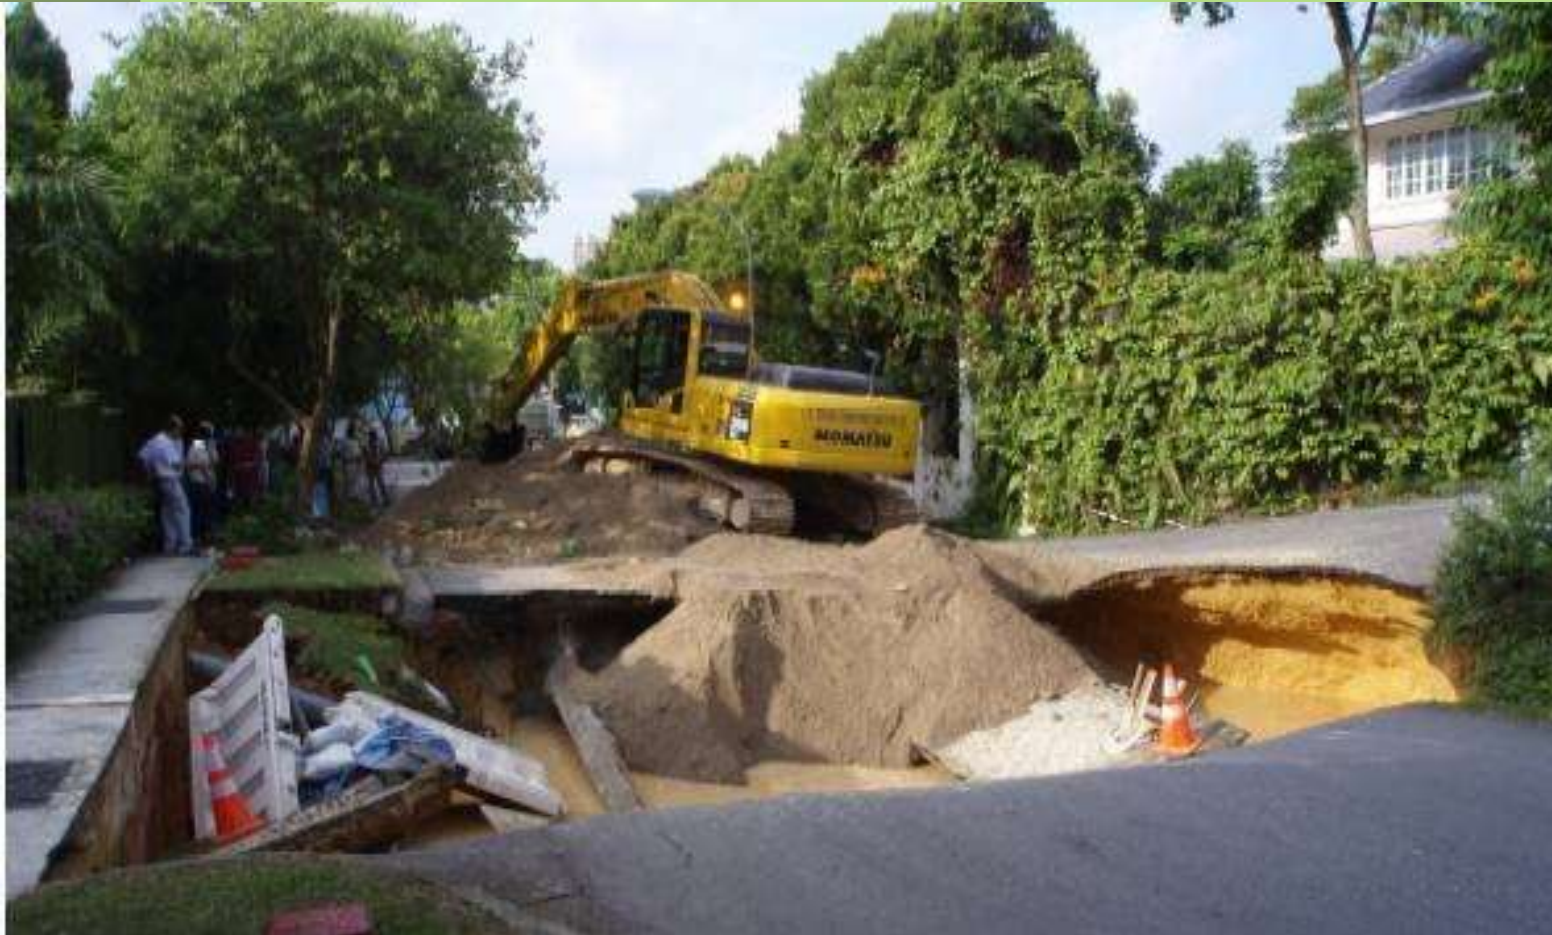
Sinkhole of:
12m (length)
5m (width)
3m (depth)
occurred on
May 2008

Tunnelling works carried out for rings 1512 to 1515 were not in accordance to the TBM Instruction Sheet. The affected rings were in transition of full-face rock (rings 1512 and 1513) to mixed face (rings 1514 and 1515).

The input face pressures (ranged from 1.2 to 1.8 bar) were much lower than the specified pressures (ranged from 2.3 to 2.4 bar). Also, some of the KPI were not controlled within the allowable ranges.

Daily TBM Excavation Meeting minutes on May 2008 recorded that the TBM face appeared to be loosened and unstable despite using compressed air for ring 1516. Additional 6 cutter head interventions were carried out within a short period of one week under mixed face condition without implementation of additional precautionary/preventive measures.

The cutter head intervention for ring 1515 was initially carried out under free air condition (instead of compressed air) and could have adversely affect the face stability. In addition, there were no records of temporary supports installed to support the unstable face. Frequent and prolong cutter head intervention under unstable mixed face could have resulted in the observed over excavation.

Large volume of over excavation was observed (estimated from relative dry weight of the excavated material) for five of the tunnel rings - rings 1525, 1522, 1521, 1518, 1515 (with excavated material dry weight ranged from 1.5 to 3 times that of for a normal ring). Daily TBM Excavation Meeting minutes also recorded an estimated over excavation of 35m³, 40m³, 40m³ for rings 1525, 1521, 1515, respectively.

The design assumed a 1.5% volume loss (approximately 0.74m³ per ring). The observed volume loss of completed tunnel was typically less than 1%. The estimated gross volume loss at the location of incident was estimated to range between 80% to 200% (based on relative dry weight).

Although over excavation was reported for ring 1515 and ring 1521 on May 2008, the project parties decided to carry on with TBM operation and to grout the voids later, after the TBM has passed through the over-excavated portion. They were concerned that the TBM might be “grouted up” when the grouting was targeted at voids near to TBM shield and cutterhead locations. However, as the TBM was operating in mixed face condition, the TBM could only be advanced slowly. The over-excavated voids eventually collapsed, causing sinkhole formed at the ground surface.

Tunnelling works were carried out not in accordance to the Method Statement for TBM Excavation Management in Mixed Face Ground. The method statement required that surface drilling and grouting to be carried out if more than 10%/15% of over-excavation was observed. However, despite observations of large volume of over-excavation for rings 1515, 1518, 1521, 1522, 1525, as early as 10 days prior to the sinkhole, tunnelling works continued without grouting.
