Lesson learnt from foundation failure cases in Singapore

By: Er. Dr Yet Nai Song

Building and Construction Authority

BE seminar 2022

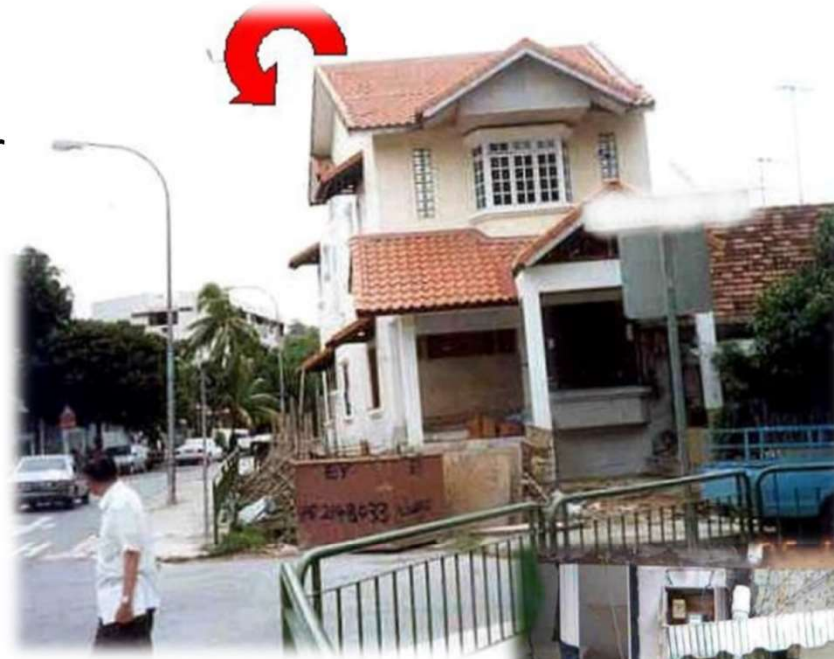
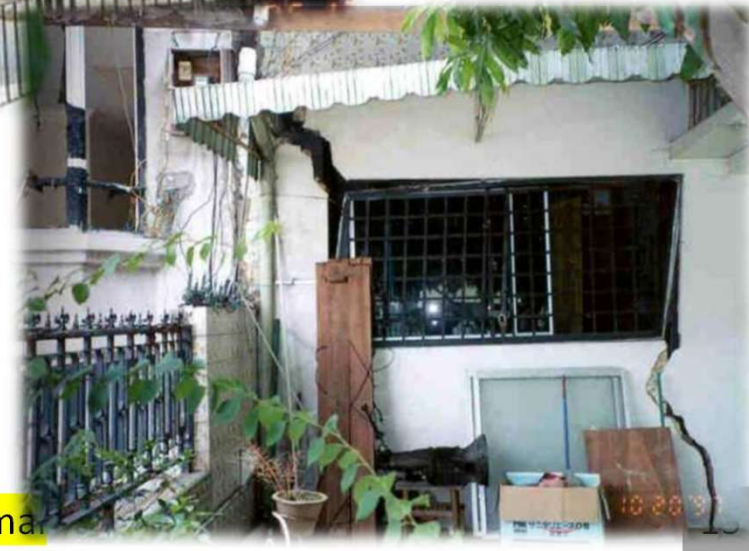
Tilt of 2-storey building on shallow foundation

- Reconstruction of a 2-storey house from a single-storey corner terrace – nearing completion
- Founded on raft foundation on bakau piles
- Building settles excessively by 655mm, and move laterally by 236 mm
- Severe damage to adjoining terrace house, with cracks as large as 200mm wide

- ❖ **Unsuitable foundation type** – raft with short bakau piles not embedded into stiff soil stratum is unsuitable.
- ❖ **Additional surcharge** acting on the founding soft marine clay due to land backfill to raise the platform level by 1.5m – not taken into design, inducing consolidation settlement.
- ❖ Excessive settlement causes the shared intermediate boundary wall to tilt & separate itself from adjacent terrace house, inducing large cracks

- ❖ Near completed 2-storey house was assessed to be not habitable, and has to be demolished and rebuilt
- ❖ Adjacent intermediate terrace house was also demolished due to the extent of damage
- ❖ Both buildings were rebuilt on RC pile foundation

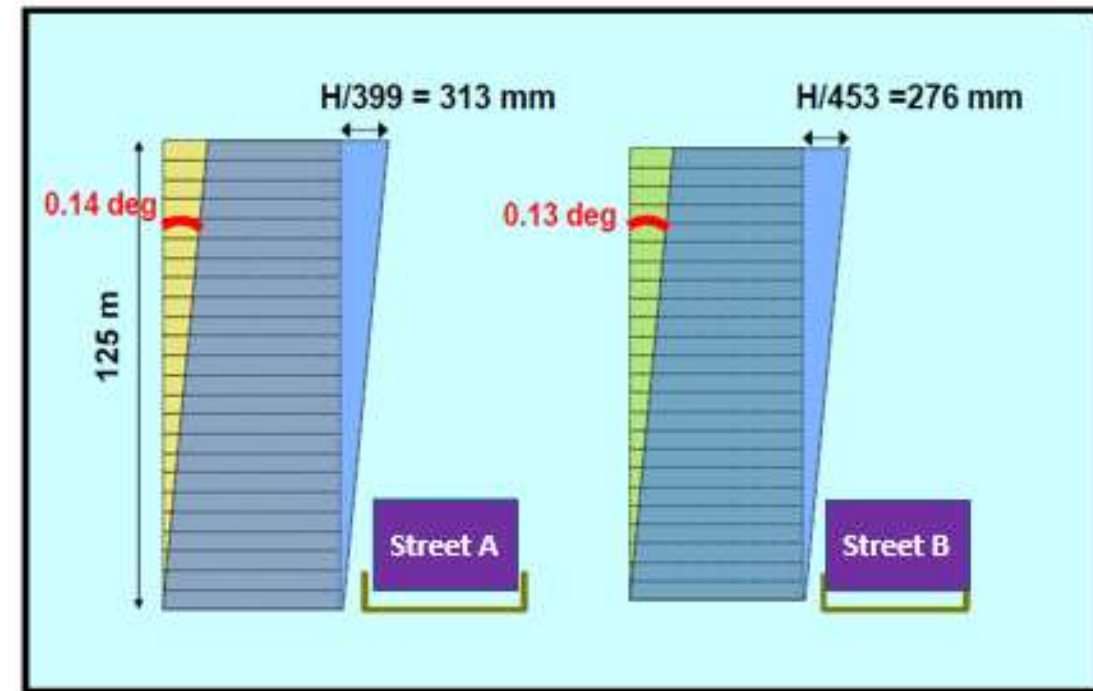
Max Recorded Tilt

- A 30-storey building nearing completion experiencing settlement at **3-4 mm/week**, posing stability concern
- QP discovered that building was tilting during installation of curtain walls
- Building was found to have tilted, with **measured lateral displacement** at roof level at 313mm in one direction and 276mm in the other direction, which translates to a tilt of to **1:399** and **1:453** respectively. This has **exceeded 1:500** limit.
- Cracks of width upto 1mm were detected on some structural members (*floor slabs and core walls*).

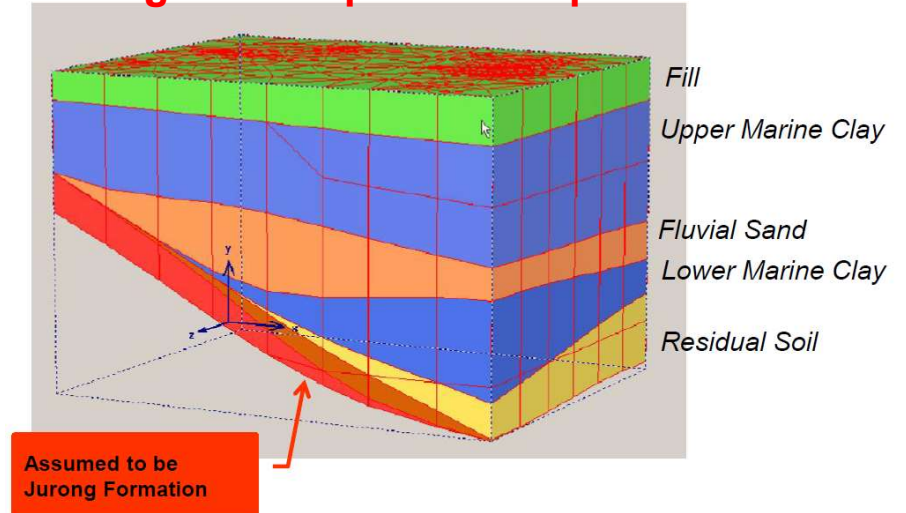
Original interpreted soil profile

- Original site investigation report has limited number of boreholes and exploration depth – the ground was mis-interpreted as **Kallang Formation underlain by Jurong Formation**
- Additional site investigation revealed :
 - ❖ Presence of **Fort Canning Boulder Bed overlying the Jurong Formation.**

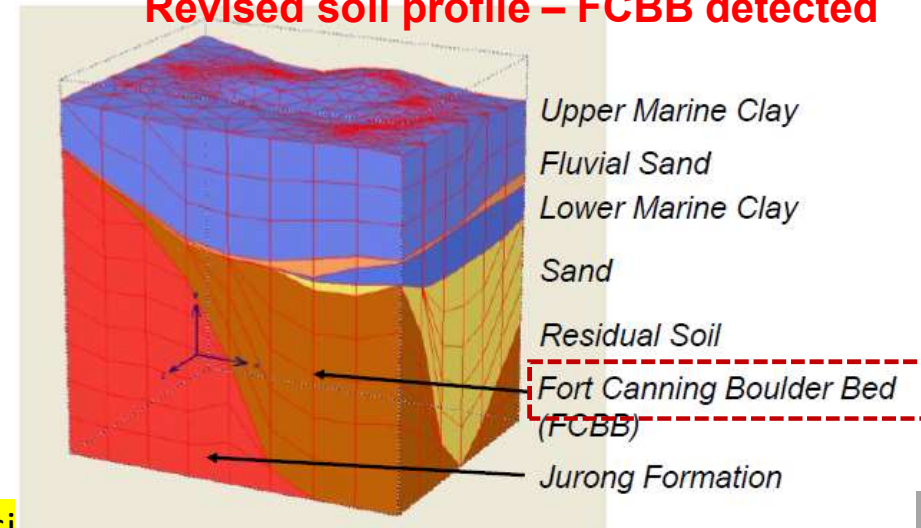
Revised soil profile – FCBB detected

- Many piles were **terminated in boulders** within soft soil matrix of Fort Canning Boulder Bed
 - ❖ not socketed a minimum 5 m into Jurong Formation with $SPT > 100$ as per original design intent
- Piles were **not sufficiently founded into Jurong Formation**
- **Highly varying pile founding stratum** – result in pile depth varies greatly from one side to the other side of building.
- **Excessive differential settlement** caused building to tilt.

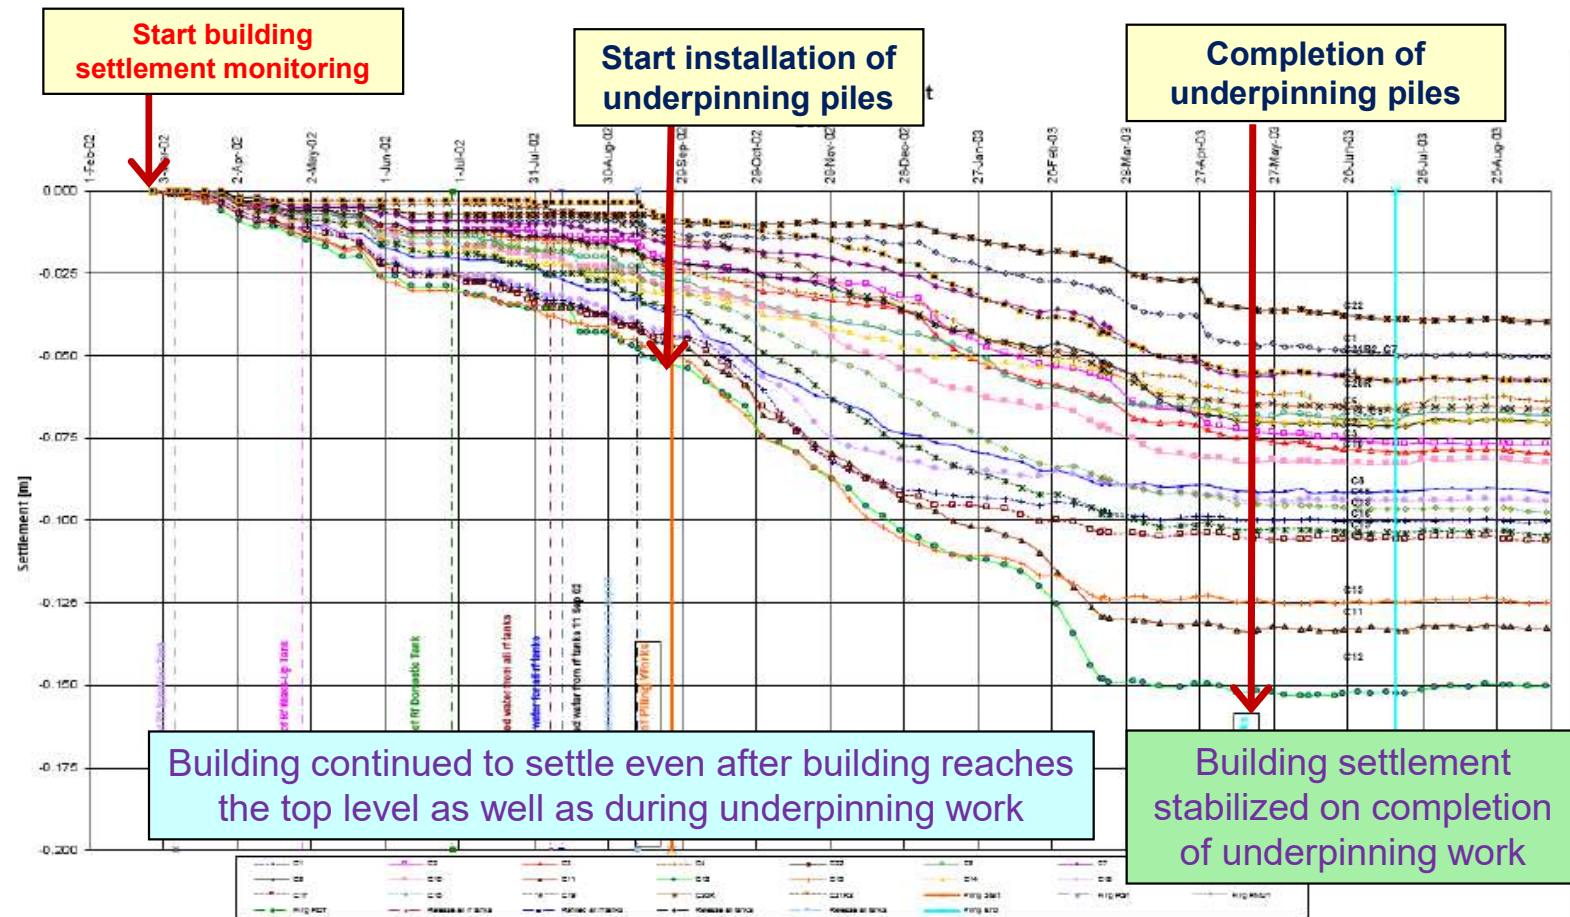
Settlement monitoring

- **Contingency plan** would be to demolish the building should the building became unstable during underpinning work.
 - ❖ Close monitoring of trend of building settlement and tilt
 - ❖ Daily inspection of building
- During underpinning work, there was additional settlement of **2 mm/week** observed
- **Building settlement was stabilized** upon completion of underpinning work.

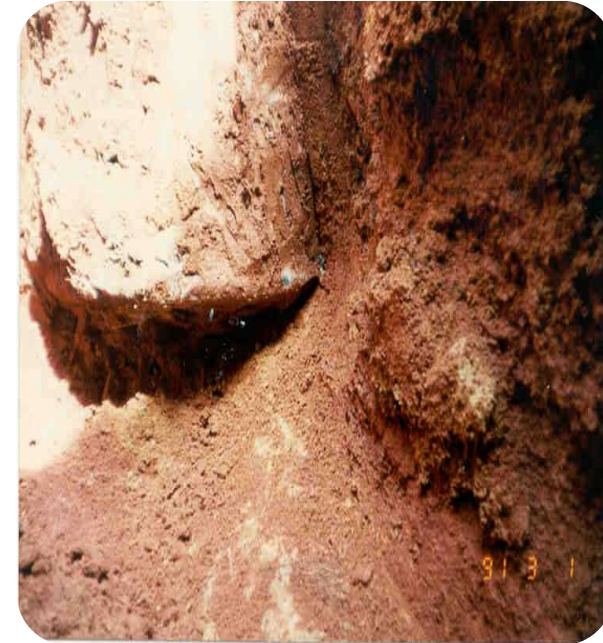
- It was found that bored piles installed were **abnormally short** of 3m to 5m, which is more than 50% shorter than the original designed depth
- Investigation revealed that piles were installed without any socket into granitic bedrock, and **merely rest on the steeply inclined bedrock.**

Pile resting on inclined slope

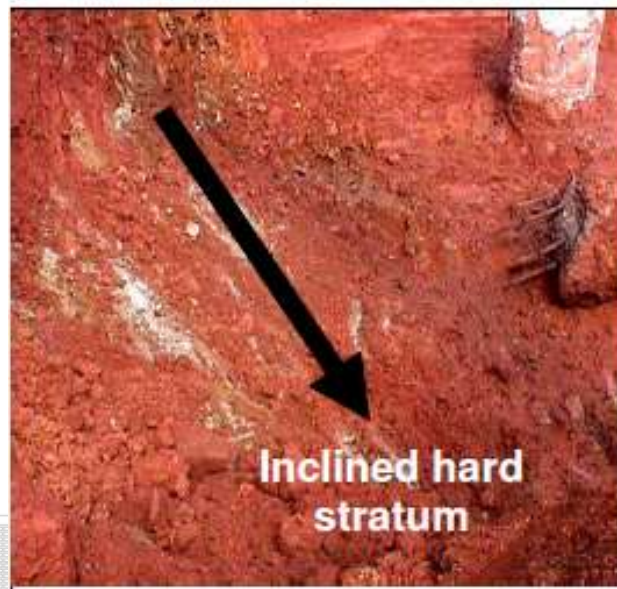
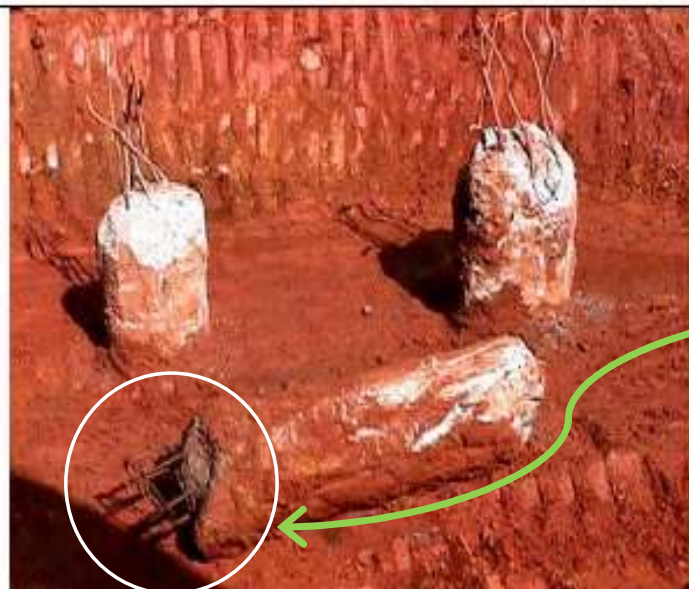
- 3 bored piles with installed depth of only 3 m were excavated for investigation, which revealed:
 - ❖ **Very steeply inclined granite rock surface** below the pile toe
 - ❖ **Poor quality of concrete at pile toe**, which dislodged and expose rebar

Poor quality concrete at pile toe, which dislodged and exposed steel rebars

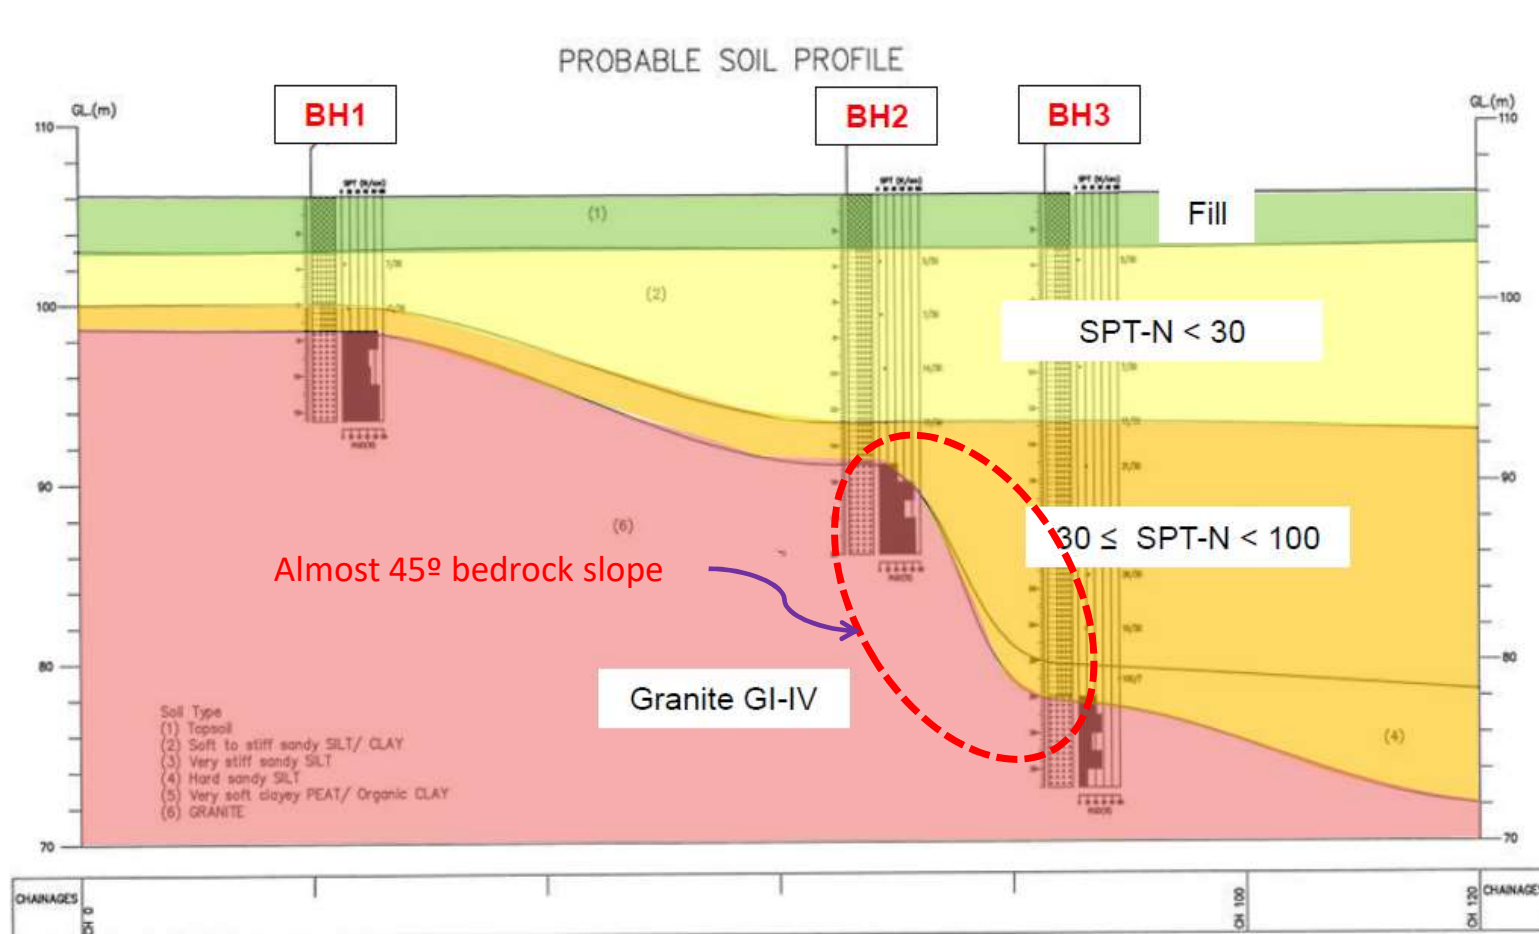
Another example of steeply inclined bedrock

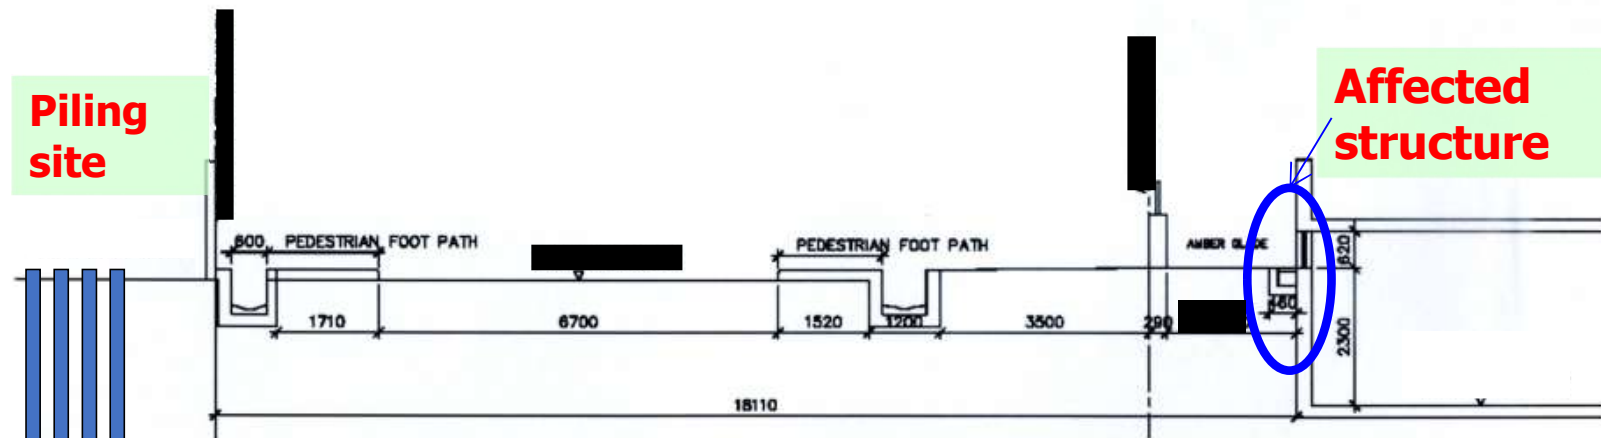
Section through piling site and affected structures

Displacement piles affected structures more than 20 metres away.

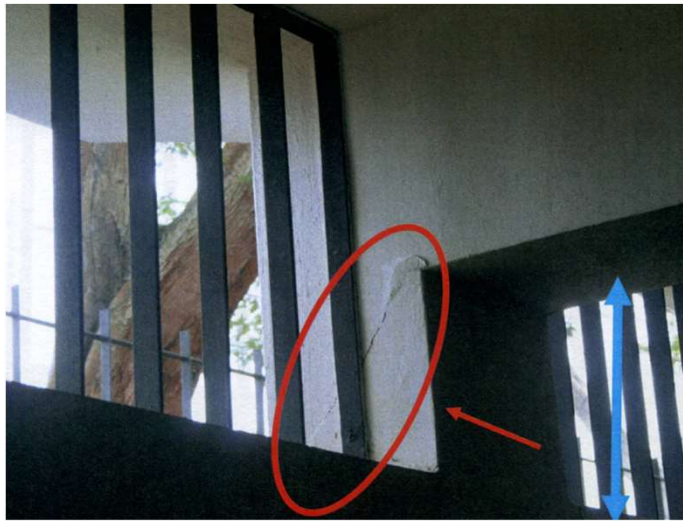
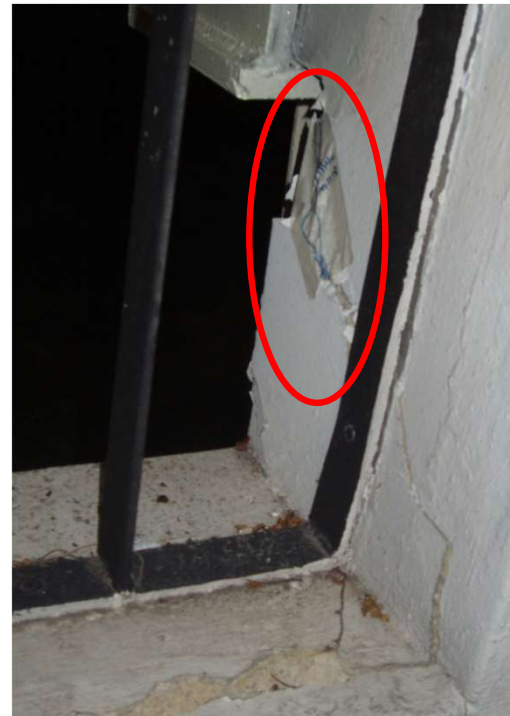
Very severe diagonal shear cracks at external column
