BCA BE Seminar 2022 Buildings: What Can Go Wrong

Lessons Learnt from Bridge Failures

Er. ZHAO ZHE Senior Engineer Building and Construction Authority

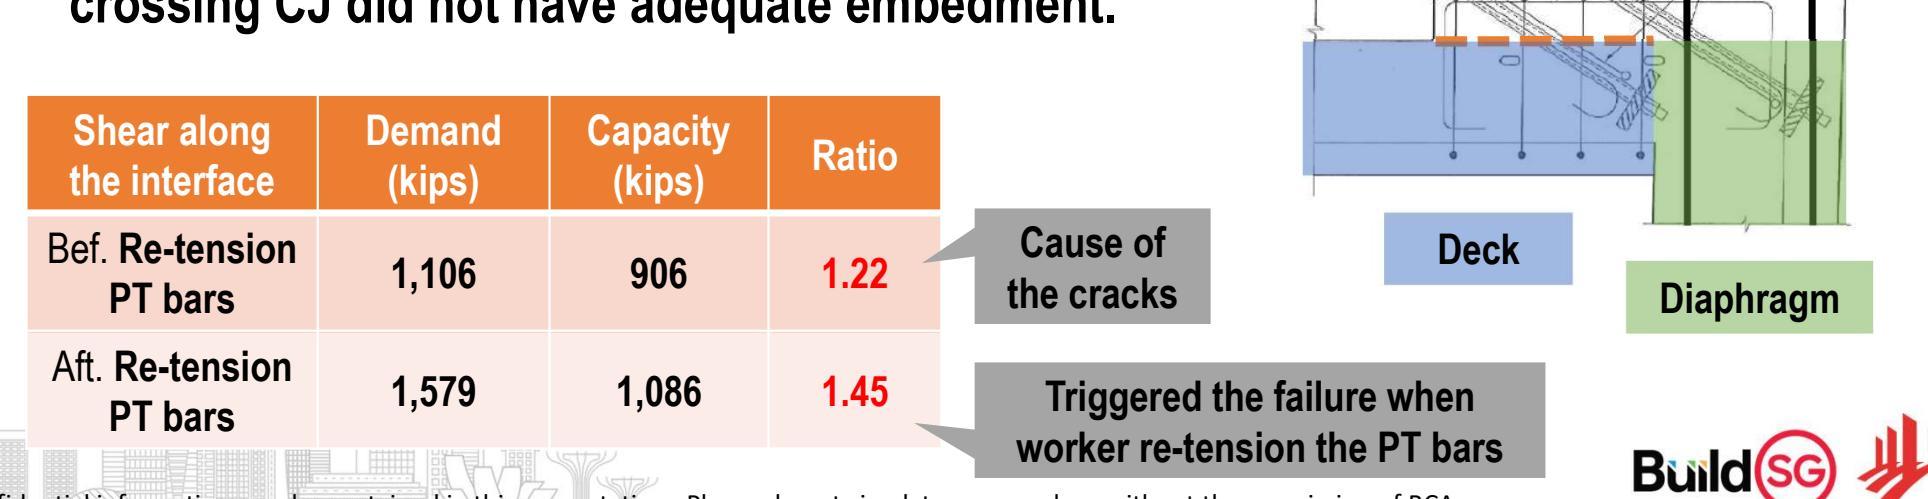
Inadequate Interface Shear Transfer

- OSHA Assessment:
 - The interface was not "intentionally roughened"
 - Other than the rebar in vertical member 12, rebar crossing CJ did not have adequate embedment.

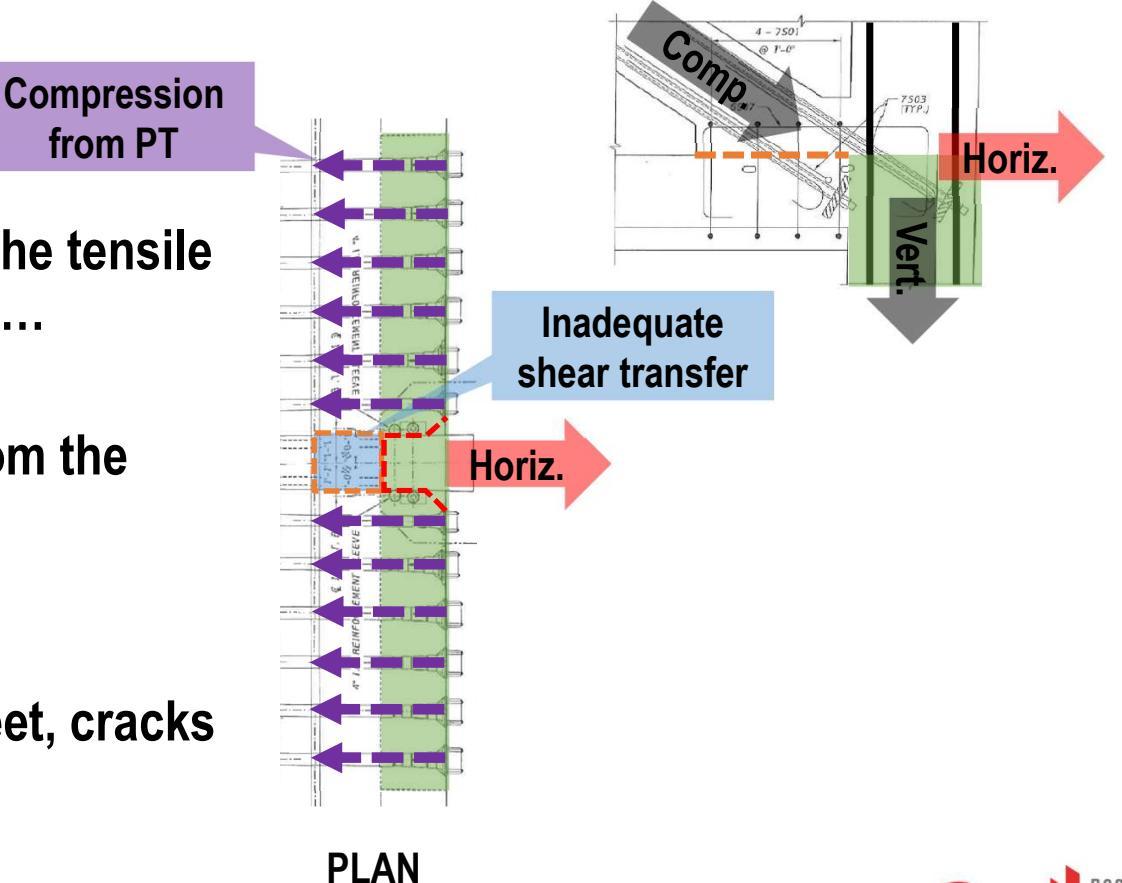
Inadequate Tension Transfer at Joint

- OSHA Assessment:
 - there is no mechanism to transfer the tensile force from the diagonal to the deck...

- the PT tendons are placed away from the junction...
- at the 45 degrees line where the compression and tension areas meet, cracks would appear..

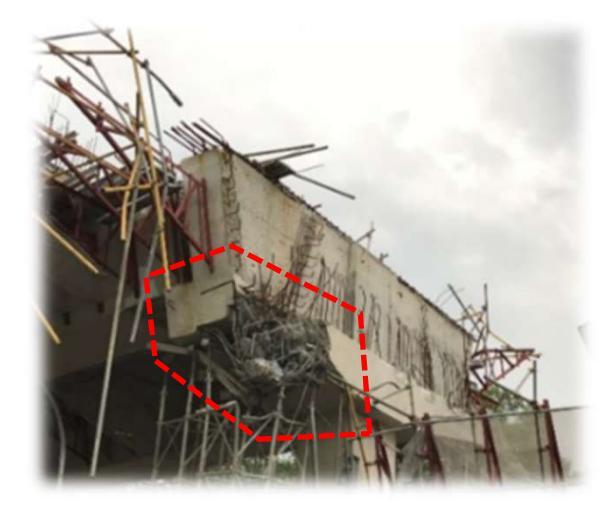
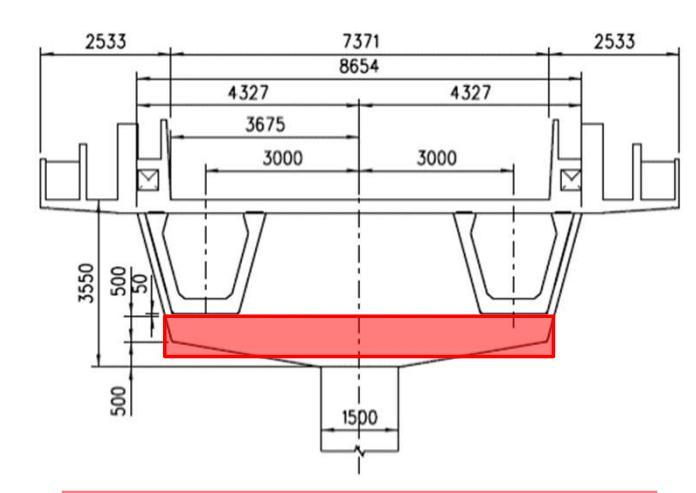
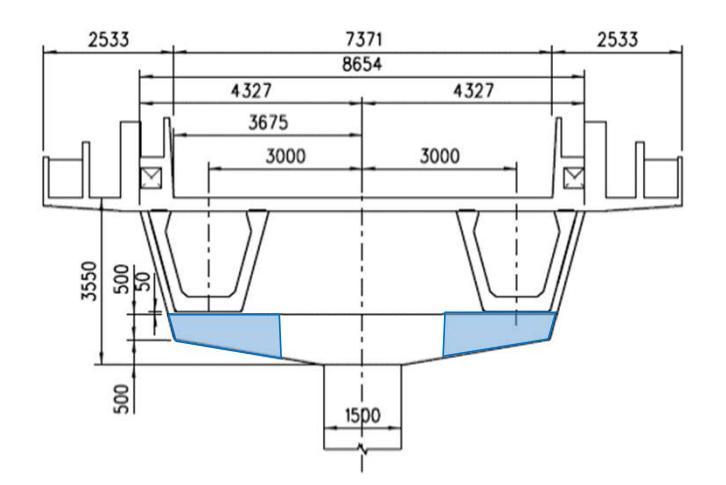
Deficiencies in Design – Temporary Corbel

Approach adopted in QP's design

• Overestimated the width and depth of corbel

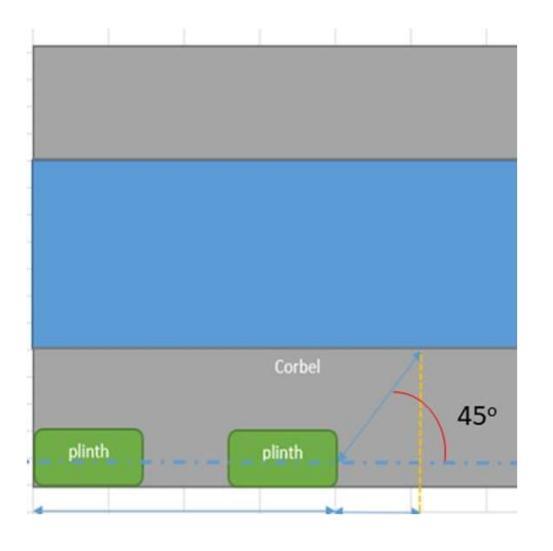
Deficiencies in Design – Temporary Corbel

Stage/Load Type	Check	Load Factor & Material Fcator	As Provided (mm2)	As Required (mm²)	CDR	
Launch (Girder Self Weight Only)	EC Compliance (Factored)	1.35 (DL), <u>γs=1.15, γc=1.5</u>	1810	2815	0.64	
	No Load or Material Factor	-	1810	1773	1.02	Any signs of distress?
At Collapse (Self weight+Const'n Live Load)	No Load or Material Factor	-	1810	2783	0.65

Assessment Result

- With the self-weight of the precast U-girder, the corbel was barely adequate if we remove all the load and material factors
- The corbel did not have enough capacity to support additional load from the casting of the deck slab

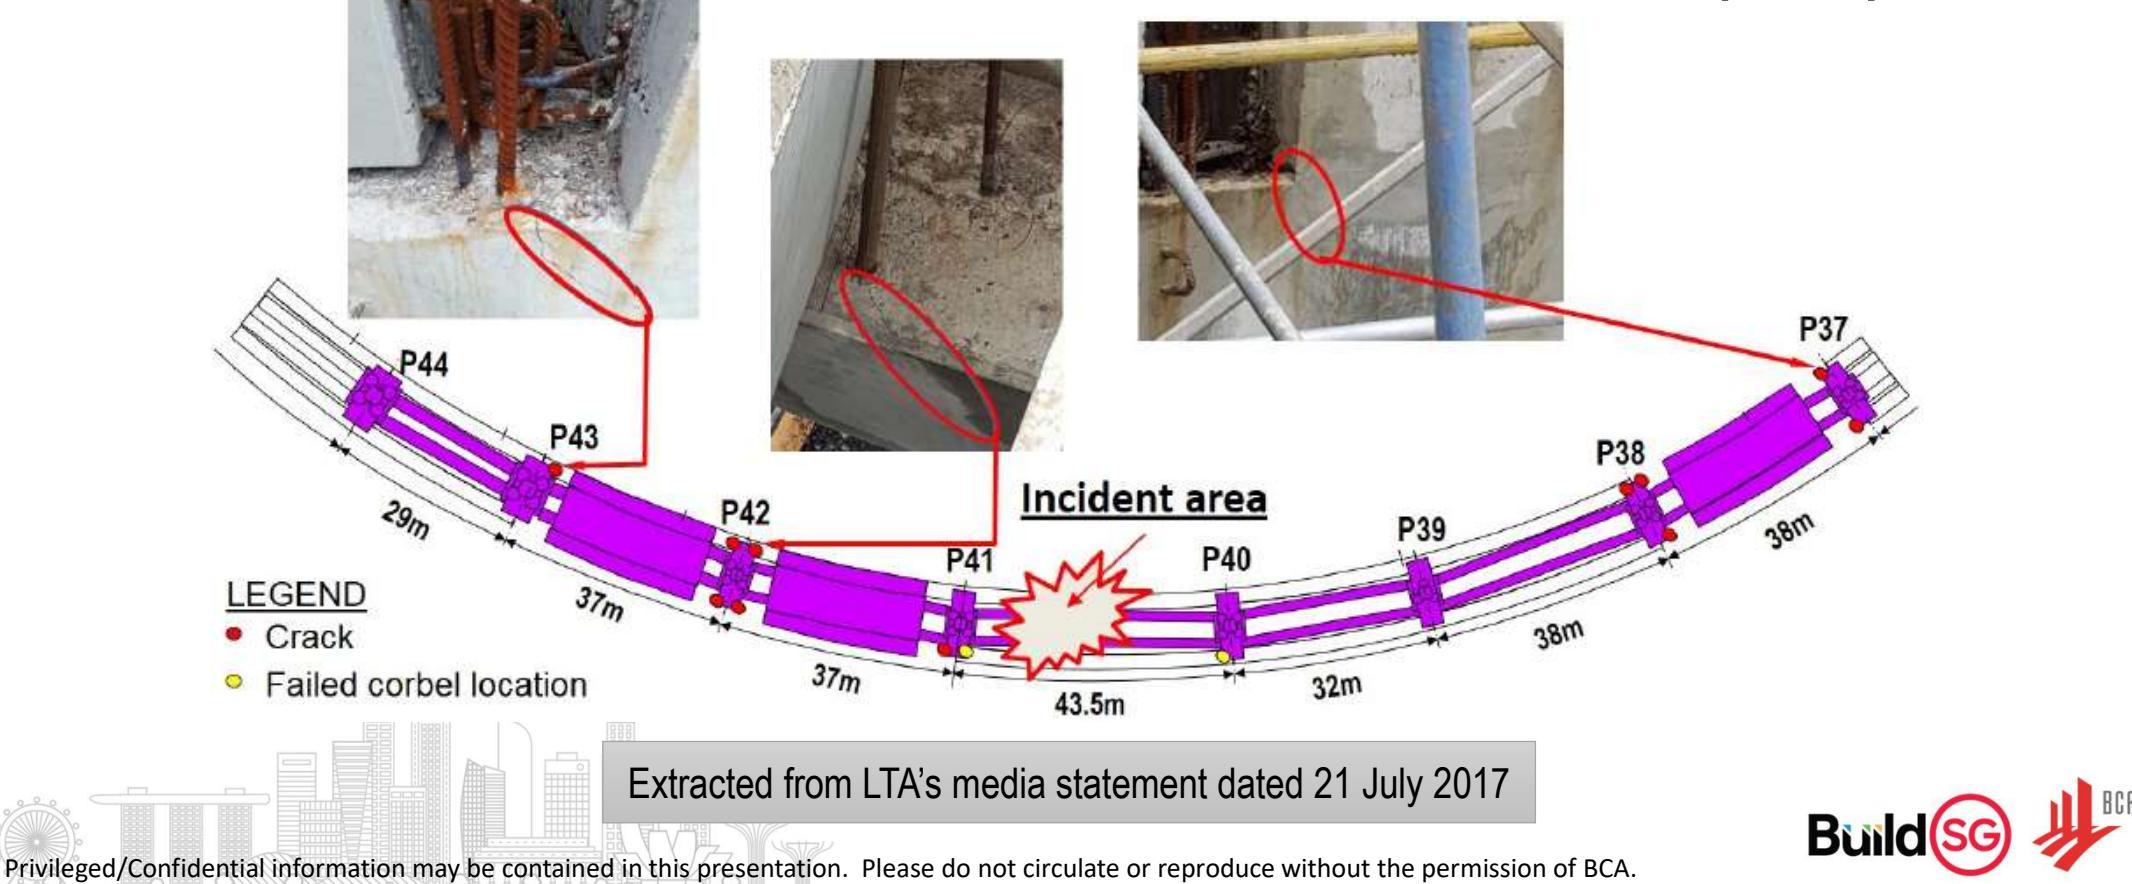
Cracks Observed

• Cracks on corbels were observed at adjacent piers before the construction of deck slab at the collapsed span.

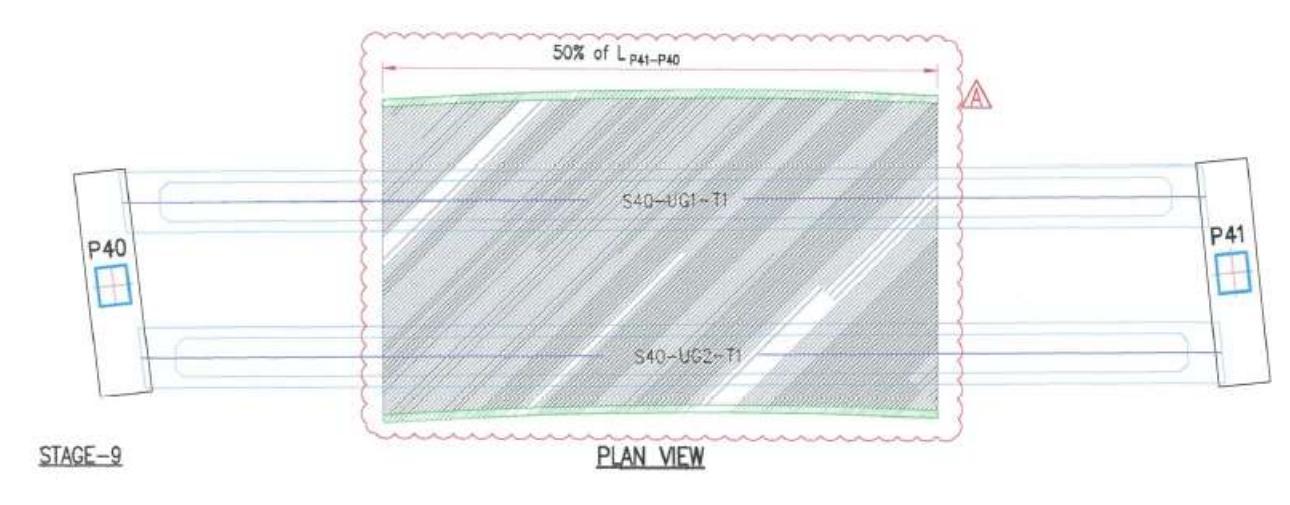
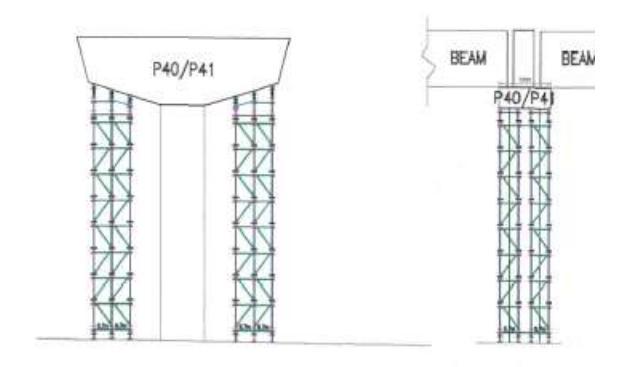
Remedial Measures

• The measures prescribed by the QP could not arrest the design deficiency of the corbels.

1. Reducing the area of deck slab from 75% to 50% of span length

2. Adding shoring below the crosshead and corbel
