TOPIC 8: ELECTRICAL ACCIDENT INVESTIGATIONS – CASE STUDIES

Case Study 1

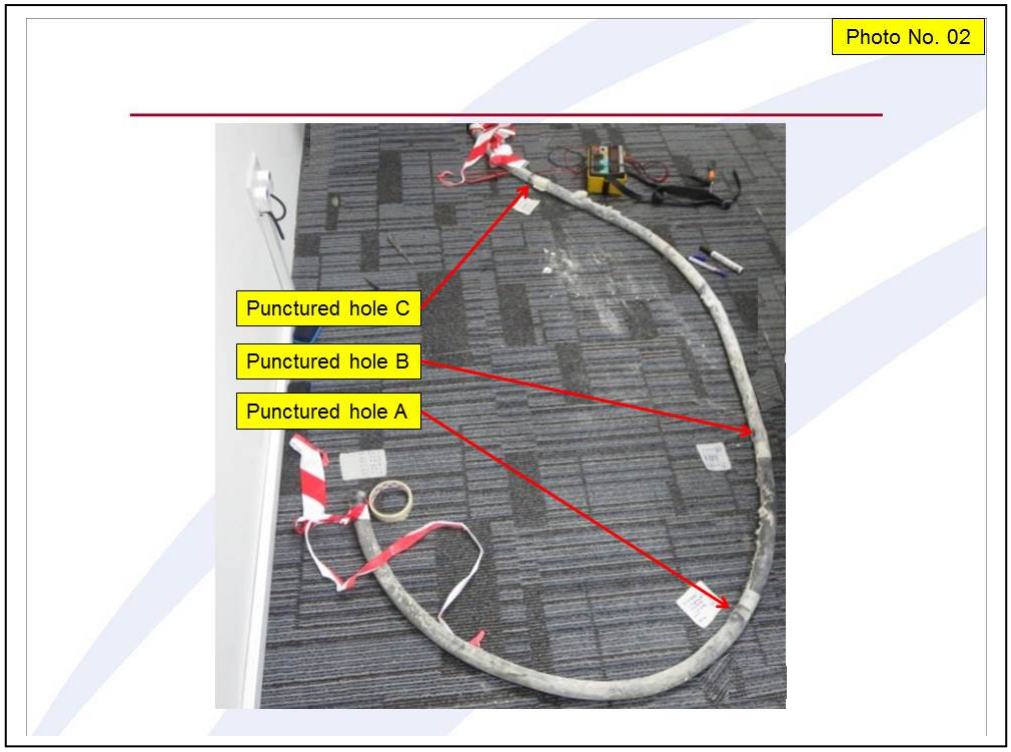
The underground work area was wet and damp, a 25mm² neoprene cable was found dangling from the wall and part of the cable was covered under the construction cement debris. The cable end was connected to the sump pump control panel (see Appendix 01). A metallic pneumatic breaker was found lying on the floor.

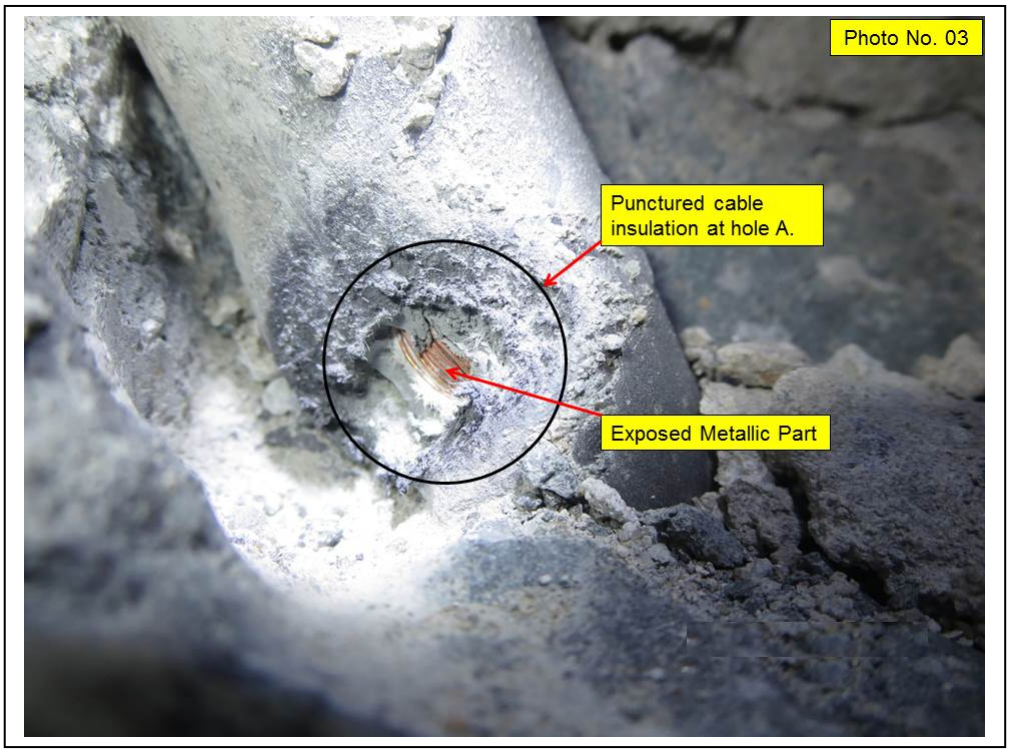
Photo No. 03
Punctured cable insulation at hole A.
Exposed Metallic Part

a. There was three nos. of punctured holes on the neoprene cable and exposed metallic conductors could be seen as shown on Photos No. 02 & 03, labeled as punctured holes A, B and C;

The accident could have been prevented if the 'live' cable and the control panel for the sump pump were decommissioned and removed before the commencement of construction work. Also, prior to the commencement of work, the cable should be checked using a voltage detector to confirm that it was not 'live' to ensure safety.

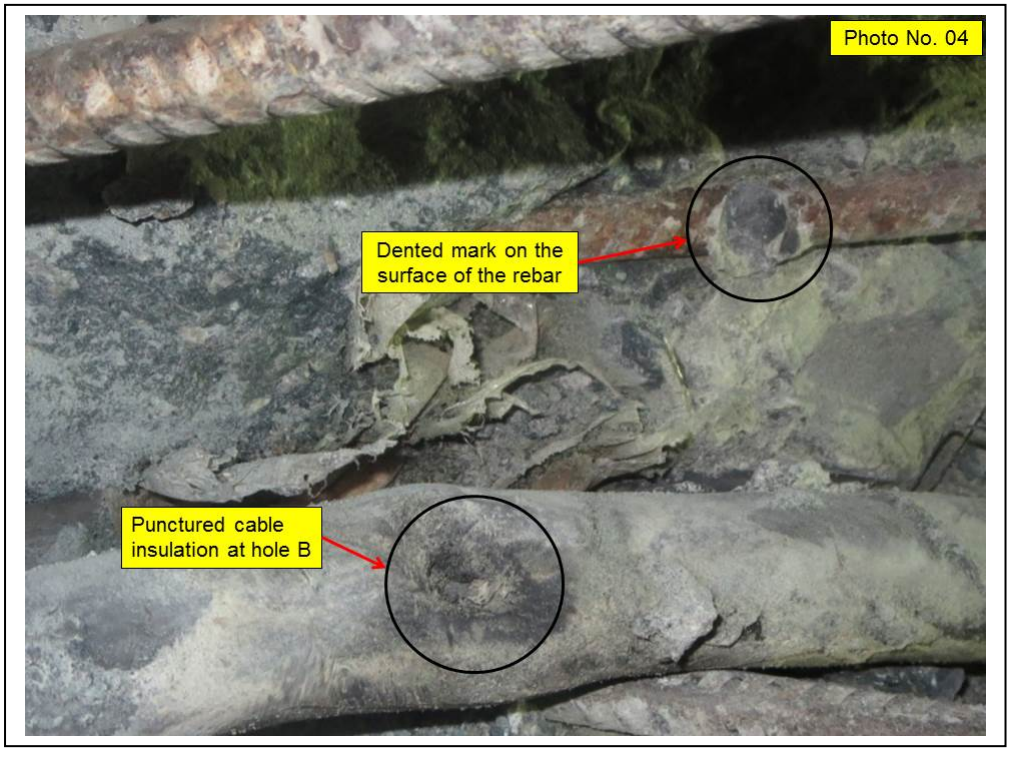
Photo No. 04
Dented mark on the surface of the rebar
Punctured cable insulation at hole B

b. There was a dented mark on the surface of a rebar found nearby, it could be caused by the chisel of the pneumatic breaker when the victim was carrying out the work (see Photo No. 04).
