Lesson learnt from foundation failure cases in Singapore

By: Er. Dr Yet Nai Song

Building and Construction Authority

BE seminar 2022

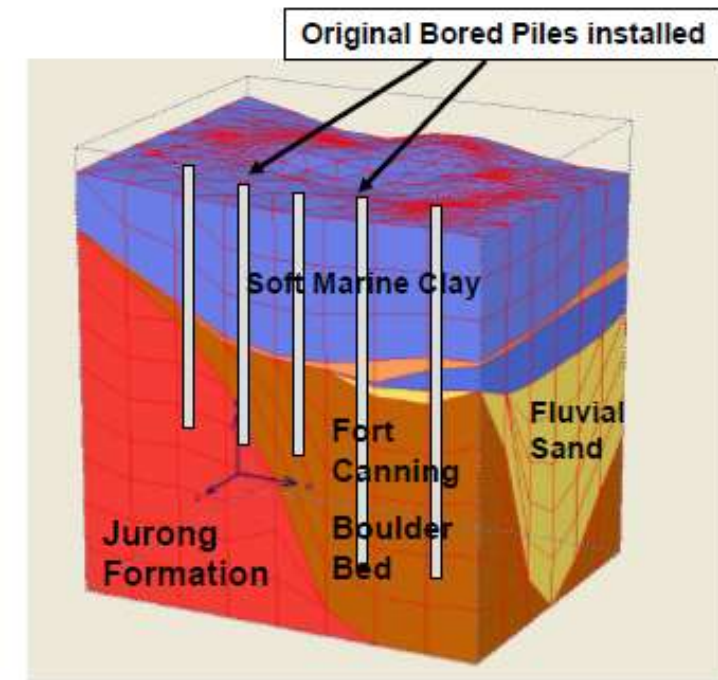
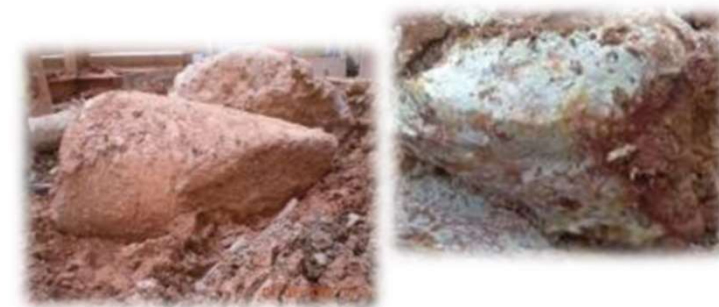
Possible causes of the tilt

- Many piles were **terminated in boulders** within soft soil matrix of Fort Canning Boulder Bed
 - ❖ not socketed a minimum 5 m into Jurong Formation with $SPT > 100$ as per original design intent
- Piles were **not sufficiently founded into Jurong Formation**
- **Highly varying pile founding stratum** – result in pile depth varies greatly from one side to the other side of building.
- **Excessive differential settlement** caused building to tilt.

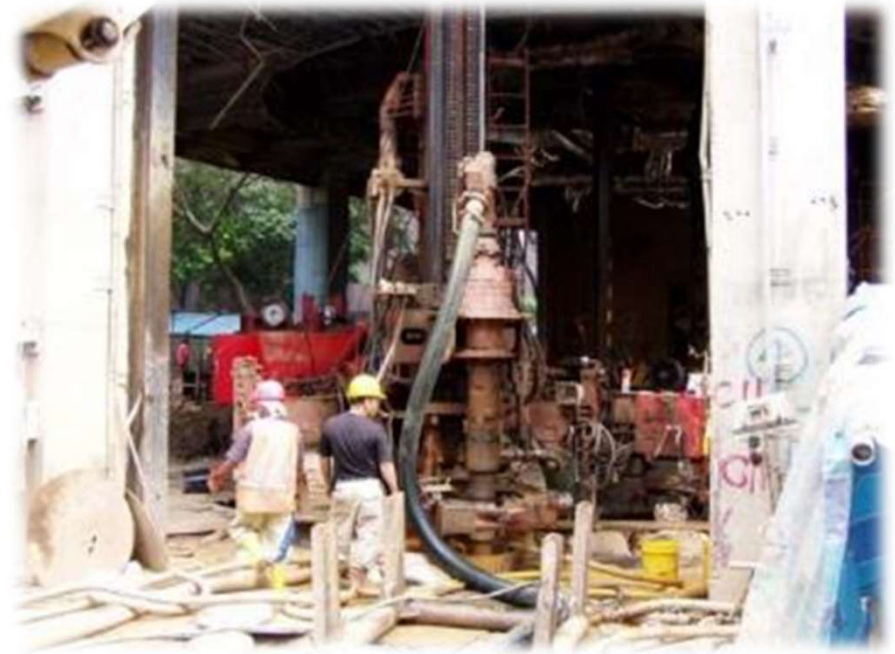
Costly rectification work

- Besides underpinning work, extensive repair and strengthening work carried out:
 - ❖ To columns, beams and slab;
 - ❖ To curtain wall
- Cost of rectification is almost the same as the original construction cost !

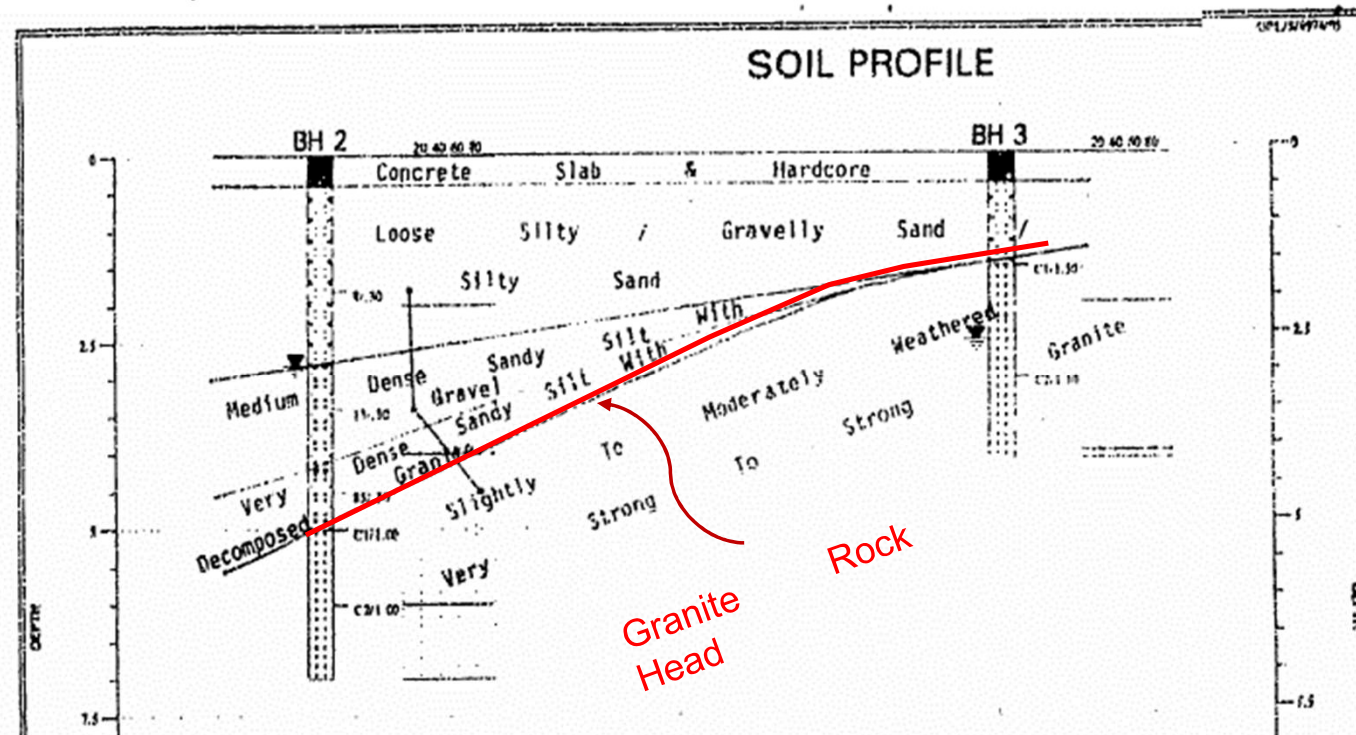
- Project involved construction of 2 blocks of 10-storey residential building, supported on bored piles in Bukit Timah Formation.
- Boreholes show the presence of granitic bedrock at shallow depth. Pile design depth was about 10m, with 4m to 7m in rock socket.

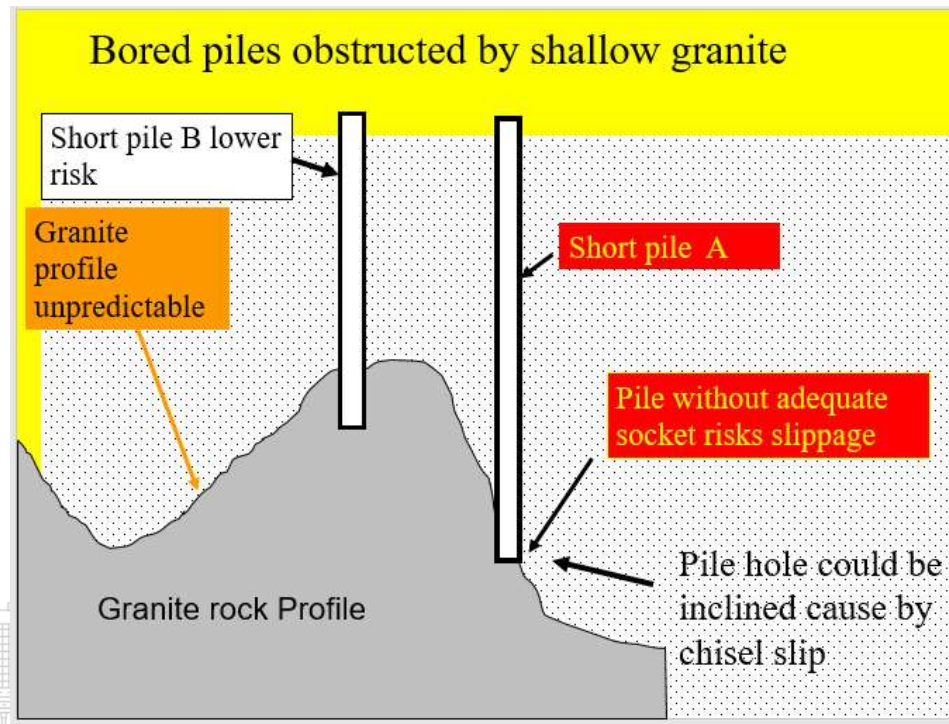
Concerns of pile installation on steeply inclining and undulating rock head

- Piles without adequate rock socket has a higher **risk of slippage on rock surface**
- Problem exacerbated if (i) chiselling slip occurs (ii) presence of rock joints that dip towards slope surface

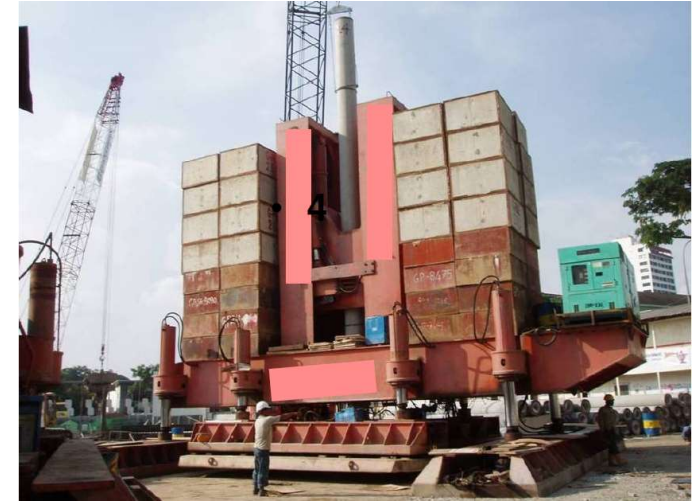
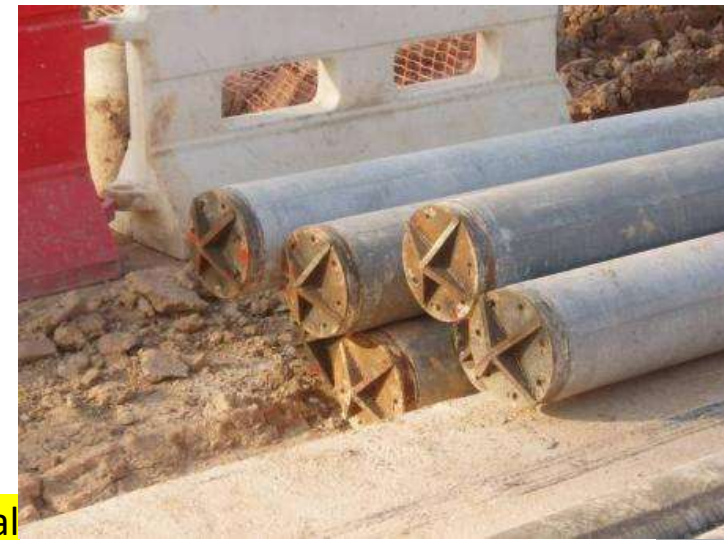
Section through piling site and affected structures

- In this project, large diameter prestressed concrete spun piles were used (300mm to 600mm Φ) to support several blocks of 20-storey buildings
- Pile depth ranges from 40m to 50m
- Piles were installed by jack in through **a thick layer of marine clay**, using 800-tonne piling machine
- *Soil displacement due to pile installation has resulted in cracks to a neighbouring building, located more than 20 metres away*

Displacement piles affected structures more than 20 metres away.

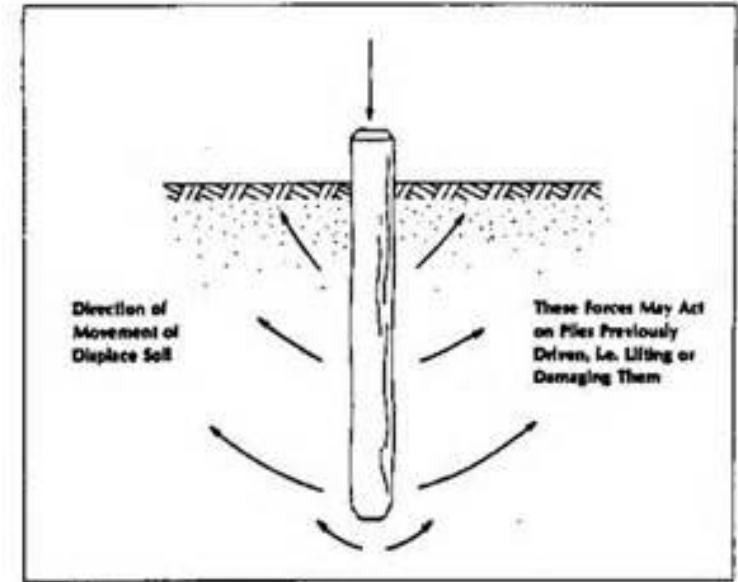
Figure 6-5. Pile action on the soil.

May affect piles driven earlier

May affect adjacent foundation and adjacent structures
