BCA BE Seminar 2022

Buildings: What Can Go Wrong

Case Studies of Excavation and Tunnelling Failure

Building and Construction Authority

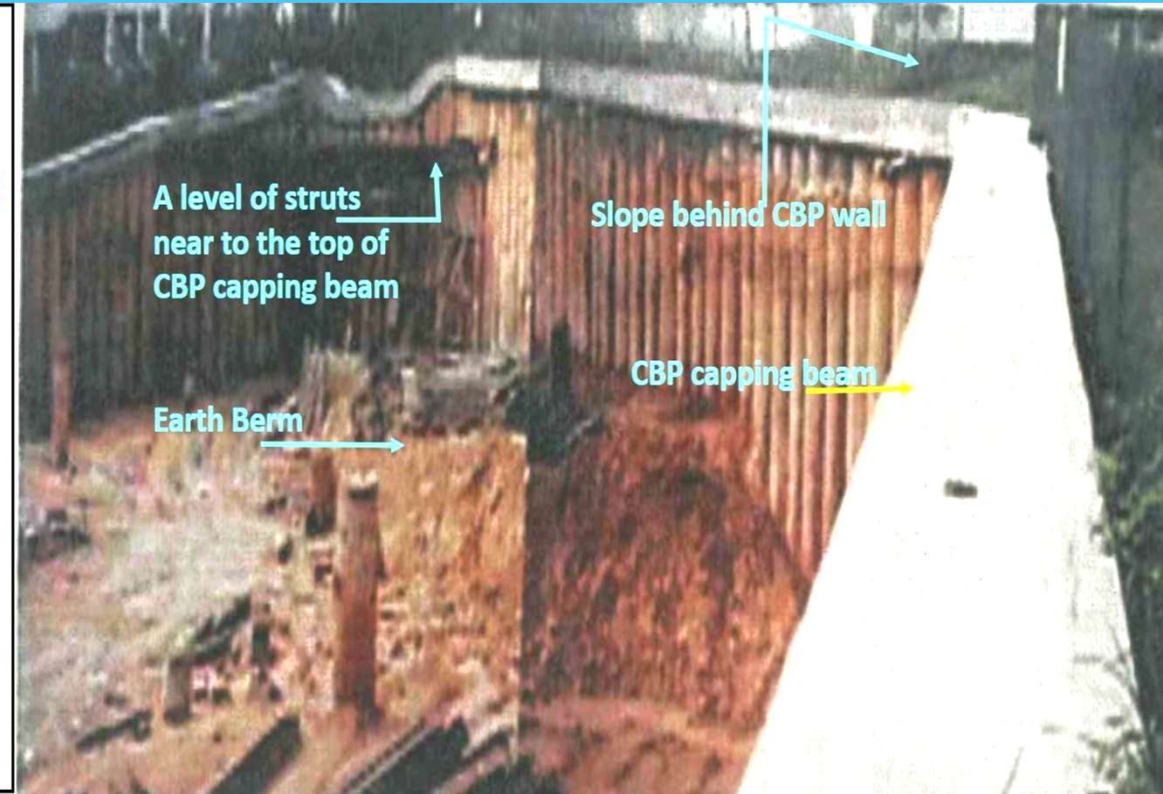
Excavation – Case 1 (CBP wall)

4-storey condominium with 2 levels of basement carpark

900/1100mm diameter CBP

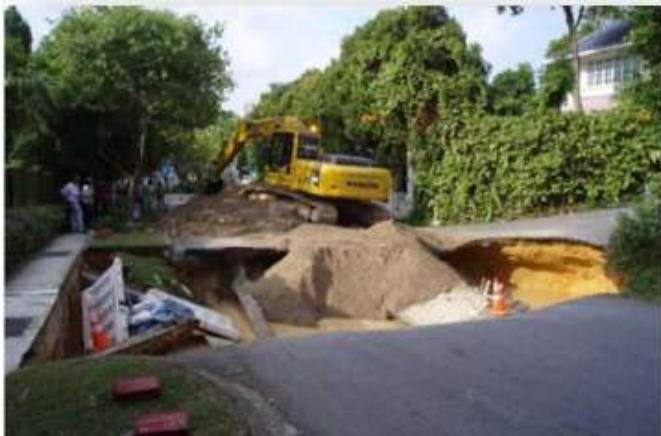
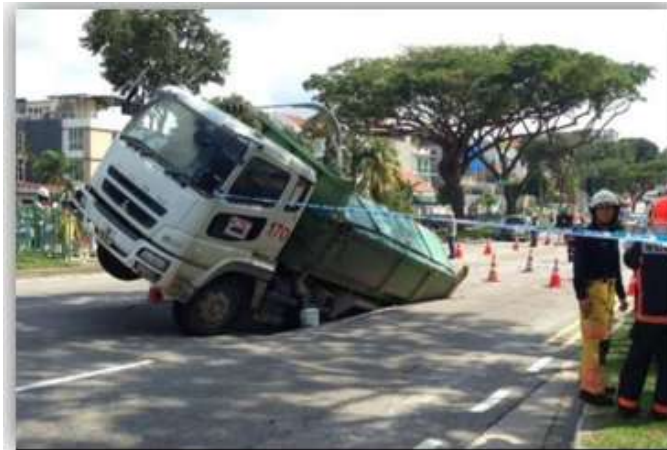
In August 2010, a hole suddenly opened up in a road in Taiyuan, China, causing the collapse of part of the nearby building of the Shanxi Provincial People's Hospital an hour later. No casualties were reported in the accident.

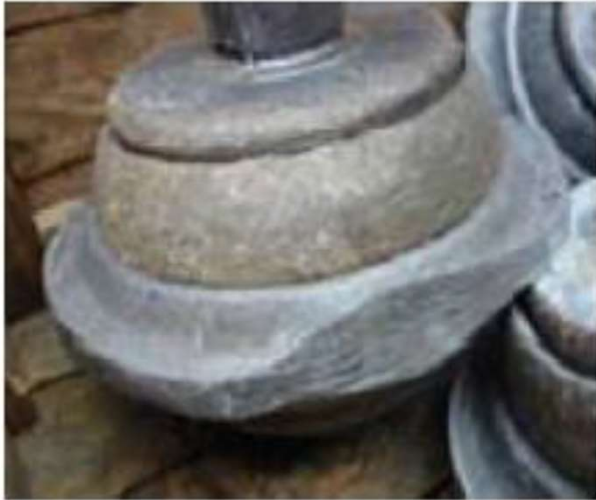
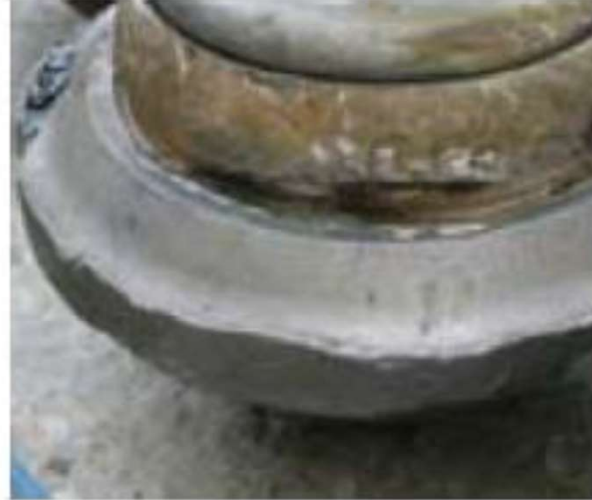
High wear and damage to cutters due to impact

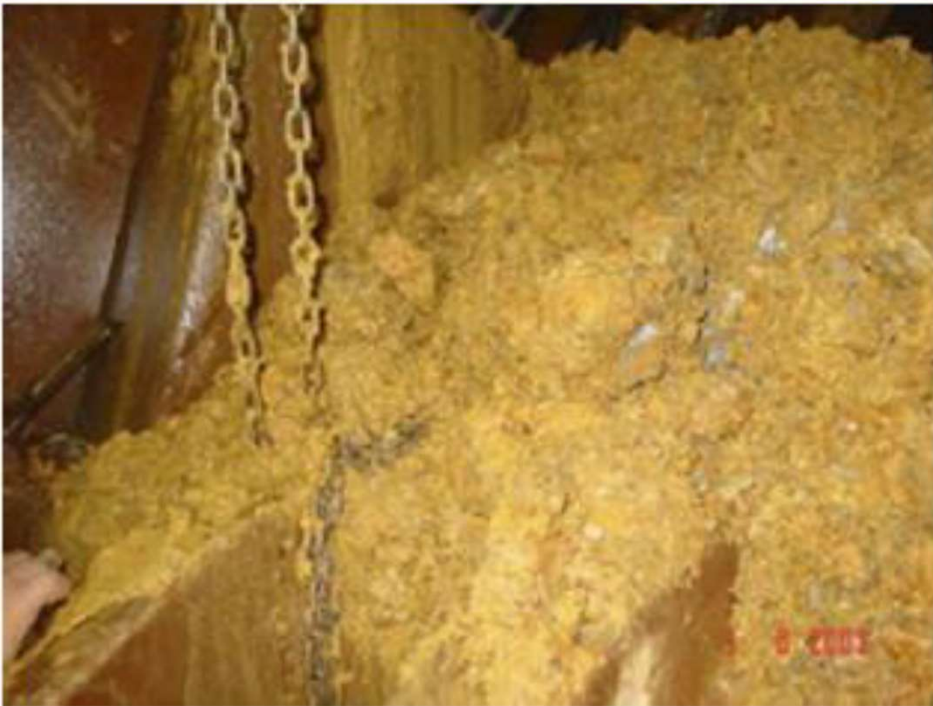
Face stability

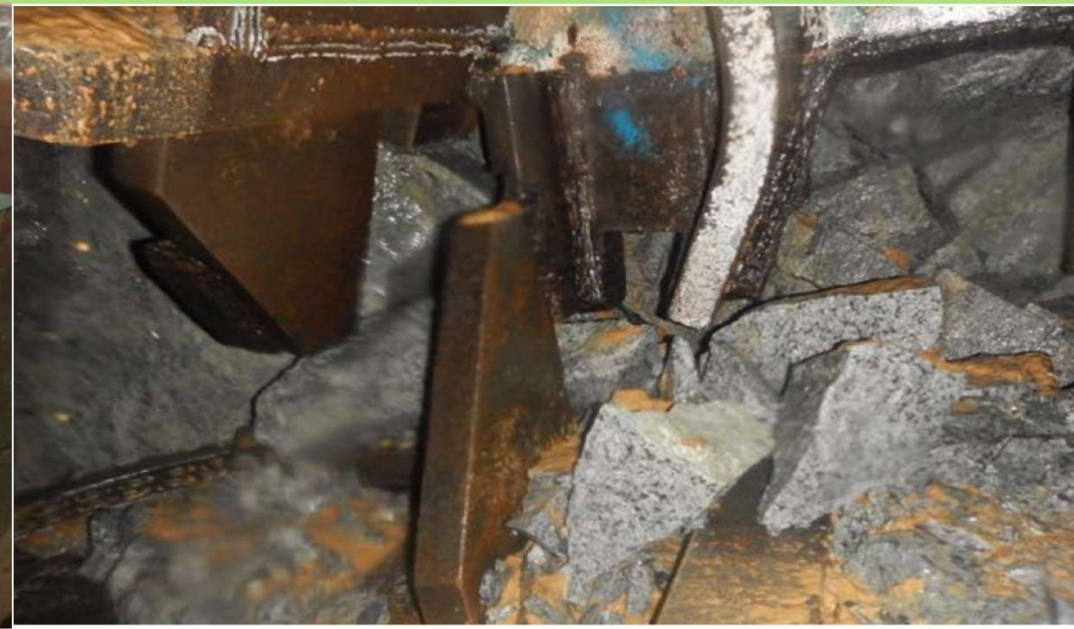
Boulders/rock debris stuck at cutterhead
